Downtown Mall Vehicular Crossings Illustrative Repair Concepts

December 2024

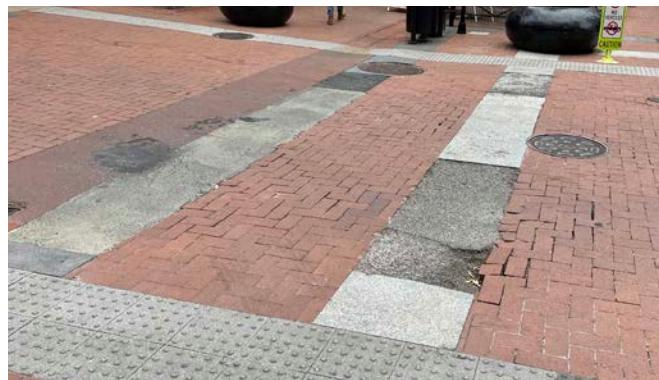
Typical condition of granite pavers. The broken pavers have been replaced with asphalt patches. The asphalt patch is not an effective edge restraint for the brick paving field so the forces acting upon the brick cannot be adequately resisted and the brick within the field of pavers have begun to deflect and move.

With few exceptions, the granite pavers within the vehicular crossings have reached a failed condition. Many of the granite pavers have been removed and patched with asphalt. Asphalt, which is a flexible paving material (as compared to a rigid paving section), is not capable of serving as an edge restraint to the brick pavers. Therefore, the brick pavers adjacent to the asphalt patches are subject to deflection and movement as is documented in the images at left.

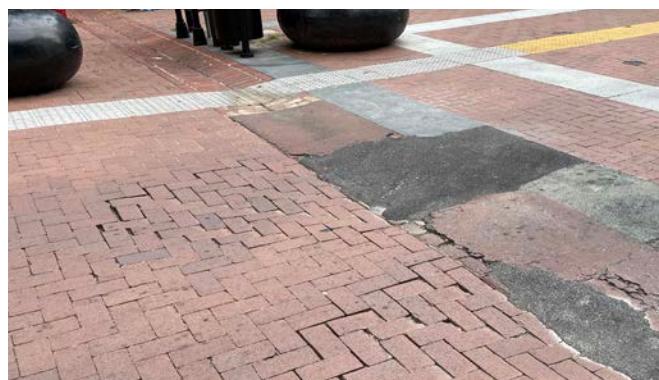
The failed drainage runnel, which was acting as an edge restraint (unintentionally), has allowed the brick paving field to begin to move as there is no firm edge available. However, note that the brick are still serviceable even though they have begun to become unstable. Tightly packed sand swept joints may have helped protect against some of this movement.

The drainage runnels within the vehicular crossing have been constructed using salvaged brick, and have been installed in a bond patterns which have continuous joints (like stack bond). Both of these parameters lead to less than desirable conditions for clay paving systems, particularly when the drainage runnel ends up acting as an edge restraint within the paving system.

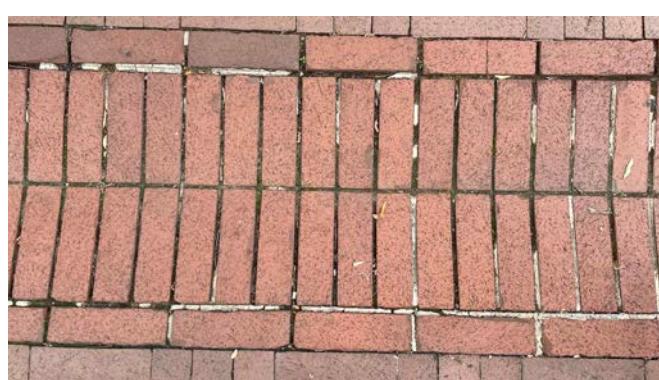
Photo represents the typical condition of the runnels on the downtown mall. Note the lack of mortar remaining between the original brick. (This photo was taken of a drainage runnel along the mall and not within the vehicular crossing because the vehicular crossing runnels have been covered with asphalt).

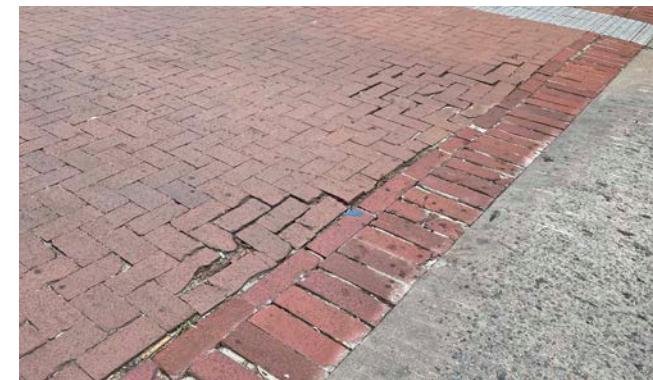
Salvaged brick banding adjacent to the concrete speed hump. Note the broken mortar, disheveled brick orientation (due to movement) and the brick paving field beginning to deflect as a result of the failed edge restraint.

The vehicular crossings are effectively constrained on all 4 sides. Two (2) sides comprised of the ADA tactile warning pavers, and two (2) sides adjacent to the speed humps entering and leaving the vehicular crossing. The edge restraint along the entering and exiting thresholds of the vehicular crossings is not the cast-in-place concrete speed hump but the mortar set brick banding adjacent to the speed hump. Similar to the drainage runnels, this brick banding edge restraint is comprised of salvaged brick set in mortar. The mortar has broken (perhaps because a mortar with the wrong material properties was used) and the bond between the brick and mortar is non-existent. As a result, this brick banding is not capable of supplying the rigid restraint needed for the brick paving field, and the lack of a firm restraint enables the paving field to further deflect.

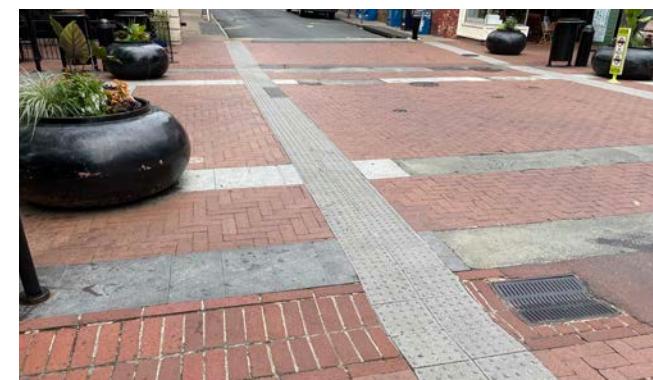
Tactile warning Pavers (12"x12") adjacent to the 2nd Street East crossing. Note the condition of the tactile warning pavers in comparison to the granite bandings which run perpendicular to the flow of traffic. The granite banding is subject to substantially more frequent vehicular loads but also different loads than the tactile warning pavers.

The edge restraints along the sides flanking the lateral edges of the vehicular crossing are comprised by the ADA tactile warning pavers which are 12"x12" pavers set in mortar. Interestingly, these pavers appear to be in much better condition than many other attributes of the vehicular crossings. With the exception of the east side of the 4th Street crossing where the ADA pavers have been replaced with a "yellow" tactile warning pad/strip (presumably because the pavers failed) all of the ADA tactile warning pavers appeared in serviceable condition. These pavers are not subject to the same forces as the rest of the pave field namely the braking and acceleration forces. That said, they are subject to rotational forces as numerous cars pull to the side of the vehicular crossing to drop off or pick up pedestrians. These rotational forces have loosened many of the ADA pavers and required many others to be replaced. Nonetheless the conditions appear serviceable.

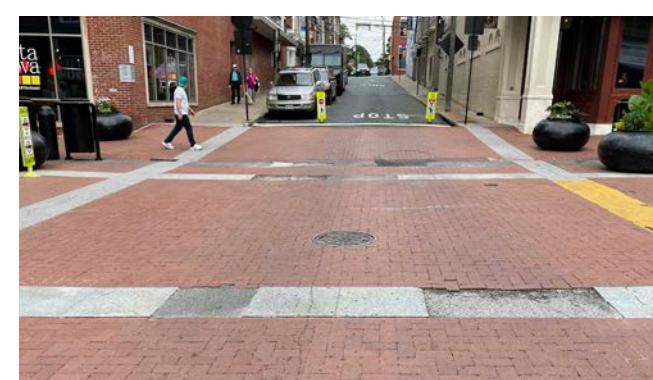
Photograph of the 4th Street East vehicular crossing indicating the serviceable and sound condition of the vast majority of the brick pavers.

With the exception of brick pavers which are adjacent to, or near to, the failed edge restraints (these pavers have deflected, migrated or otherwise indicate disrepair) the brick paving fields themselves are in remarkable condition. This is interesting because so much of what characterized the vehicular crossings is a "failed condition". Nonetheless the brick paving fields, and by brick paving field we mean a large uninterrupted area of brick pavers, appear fully serviceable and in sound condition.
