Memorandum

FROM: Daniel C. Hyer
Line and Grade Civil Engineering

DATE: December 5, 2023

RE: Oakwood Cemetery Forensic Investigation

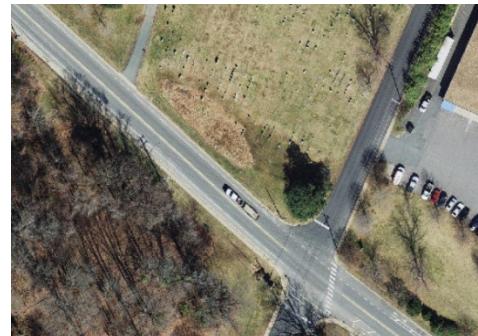
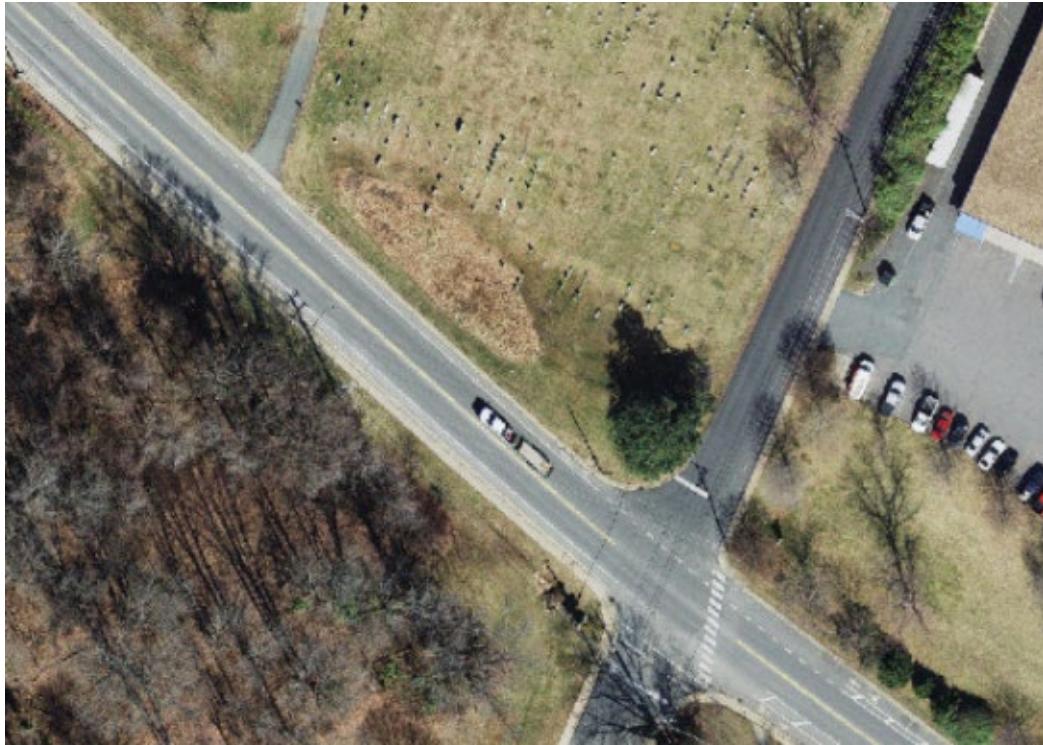
Figure 2 – Aerial image showing saturated condition of Oakwood Cemetery near the intersection of Elliott Avenue and 1st Street South.

Figure 2 - Aerial image showing saturated condition of Oakwood Cemetery near the intersection of Elliott Avenue and 7th Street South.

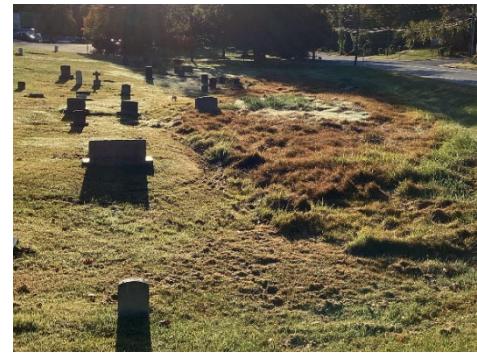
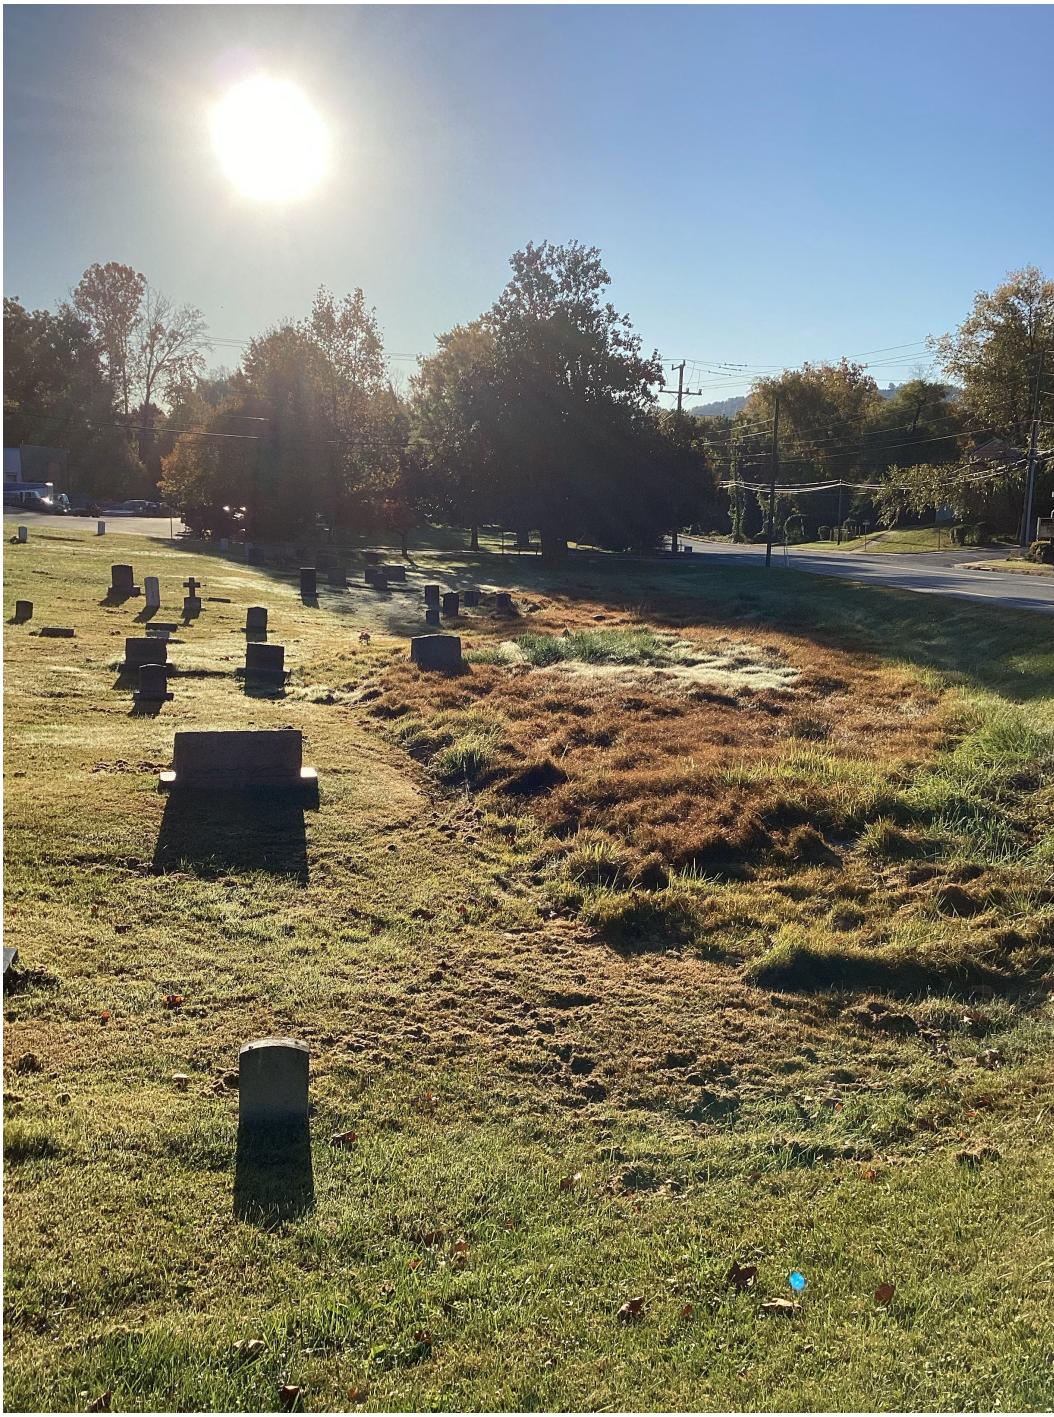
Figure 3 – Showing the area of saturated ground within Oakwood Cemetery.

Figure 3 - Showing the area of saturated ground within Oakwood Cemetery.

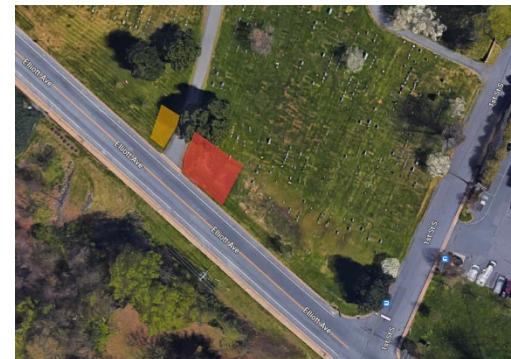
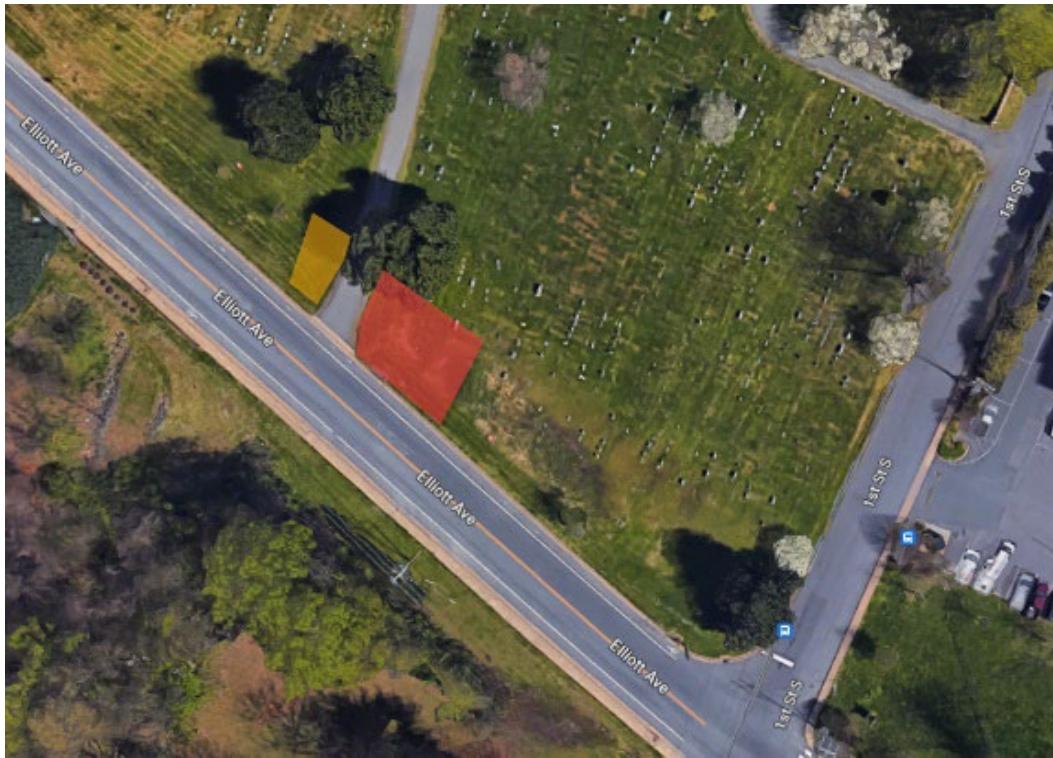
Figure 9 – 2023 GPR Scanning associated with this study. Orange shade is successful scanning area. Red shade is unsuccessful scanning area due to soil saturation.

- When NAEVA performed a GPR scan in 2017 there was enough "dry" soil to delineate some number of burial sites. Whereas, the GPR scanning performed by our team in 2023 experienced difficulty to scan some of these same areas due to the saturated condition. However, it is noteworthy that NAEVA also had some areas which must have been wet when their scanning was performed – given the strange shape of their scanning limits.

When the groundwater elevations have been sufficiently lowered, and the ground in the vicinity of Division G has been deemed "dry," the entire vicinity should be re-scanned with a GPR device. Neither the NAEVA Geophysics, Inc. GPR scanning nor the scans performed for this forensic evaluation could conclusively map all the grave sites in the vicinity due to the saturated ground conditions. The ability to revisit the area and scan under ideally dry conditions will provide the degree of confidence required to perform necessary repairs to the stormwater infrastructure.

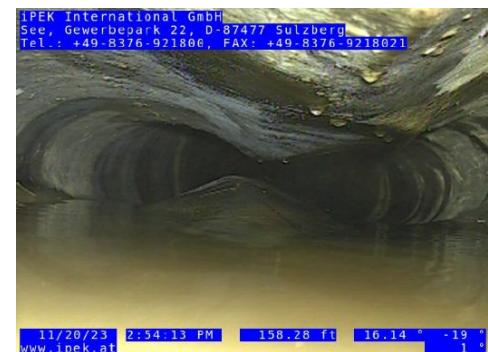
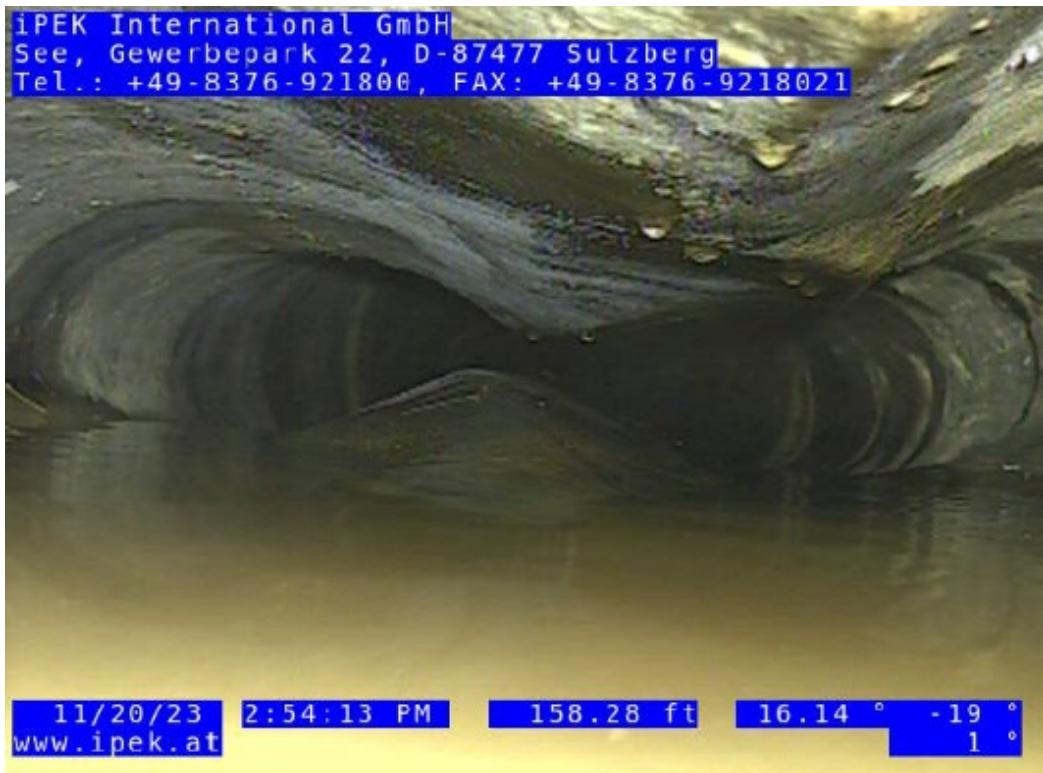
Beyond the discovery of additional stormwater infrastructure, the CCTV scan revealed that a pipe directly adjacent to the intersection of the cemetery road and Elliott Avenue had been crushed, refer to Figures 20 and 21. The pipe had been crushed to the point where the CCTV pipe rover module could not pass through the pipe. On the upstream side of the crushed pipe a volume of standing water was observed. The crushed pipe appeared to be of a polymer-based material.

Subsequent conversations with City staff revealed that the pipe had been lined in 2016 and that the City was aware that a portion of the pipe was "sagging." This suggests that in 2016 the line was exhibiting evidence of distress, but that the distress had not yet reached the level of disrepair observed in our recent CCTV survey.

Figure 20 – CCTV image upstream of a crushed pipe along the cemetery road adjacent to Elliott Avenue. Note the volume of water in the pipe.

- Between 2016 and 2023 the lined pipe has crushed. This crushed pipe has created a volume of standing water upstream of the crushed area. The crushed pipe may have also cracked, as evidenced by water dripping in through the top of the pipe. It is likely water is also leaking out of the pipe as well.

Figure 20 - CCTV image upstream of a crushed pipe along the cemetery road adjacent to Elliott Avenue. Note the volume of water in the pipe.

Based on the condition of the infrastructure in the vicinity of Division G at Oakwood Cemetery, the limits of the repairs are subject to discussions and coordination with the City. At the very least, the reach of pipe which is crushed needs to be replaced. However, there is a record as early as 2016 that this pipe was sagging, and as such it should be further evaluated whether there are additional factors which are causing this pipe to deflect and break. This can be determined during the archaeological work defined in 6.3.1.

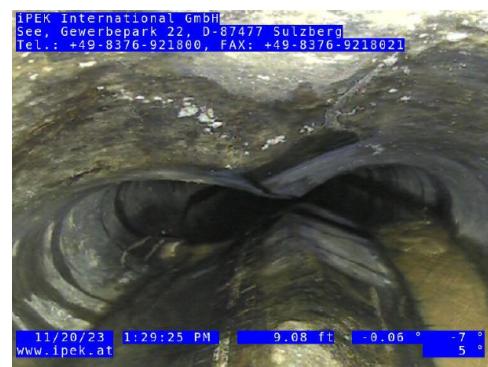
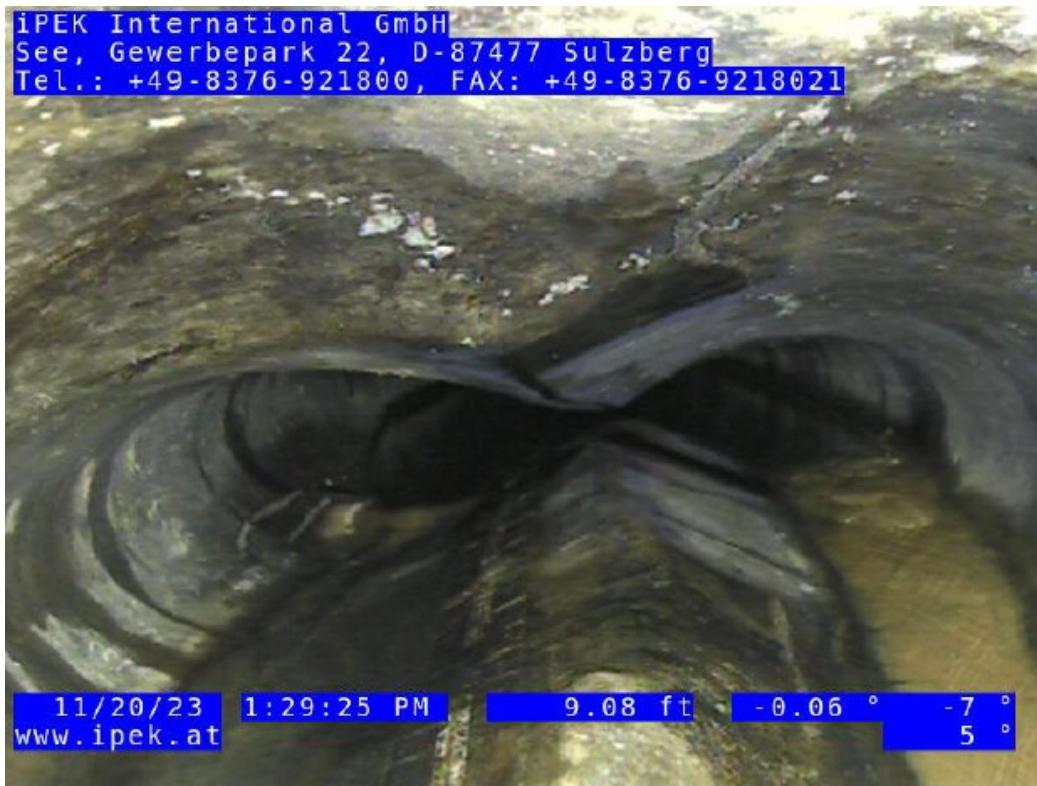
Video evidence from this area where the pipe has been crushed revealed that water leaking was into the pipe from the top. The leak appeared as a constant drip. It

Figure 21 - CCTV image downstream of a crushed pipe along the cemetery road adjacent to Elliott Avenue.

cannot be conclusively determined if this leak is groundwater flowing into the pipe or if it is condensation within the pipe. It is possible that the polymer-based lining had flexed under the crushing forces and that cracks may also be present. If indeed cracked, and based on the visual evidence of water dripping into the pipe, it can be proposed as a hypothesis that there are cracks on the bottom of the pipe as well and that these cracks allow water to seep into the soil surrounding the pipe. At this point it is important to recall that this pipe carries water which was at one point a tributary, and there is likely a base flow of water constantly flowing through this pipe. Under the present conditions it is likely this water is also constantly leaking out of the pipe as well. The video footage also suggested an abrupt change in the pipe material slope, which corroborates City staff's insight that the pipe had sagged or otherwise deflected under the crushing forces.

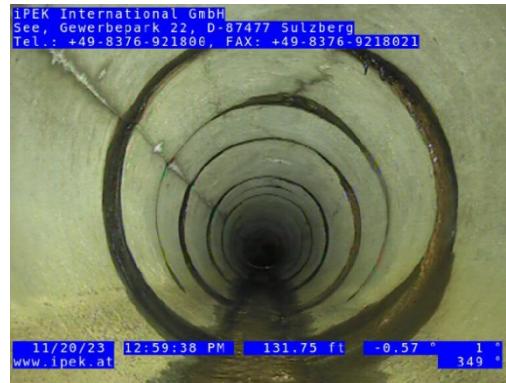
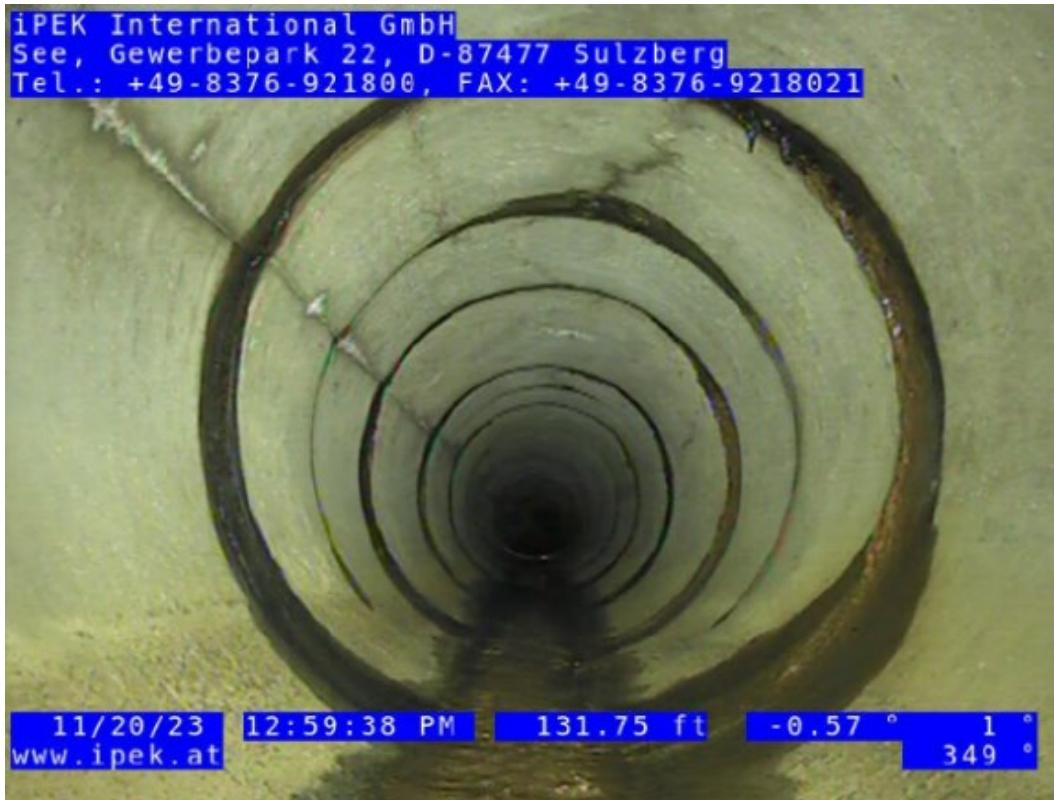
Figure 22 - CCTV Image within the 36-inch RCP pipe along Elliott Avenue. Note the wet seams along every pipe joint.

- Water was observed to be leaking through every joint of the 36-inch RCP pipe under Elliott Avenue.
- A blind pipe connection had been made to the 36-inch RCP pipe providing for water from within a French drain system to flow into the Elliott Avenue system.

Figure 22 – CCTV Image within the 36-inch RCP pipe along Elliott Avenue. Note the wet seams along every pipe joint.

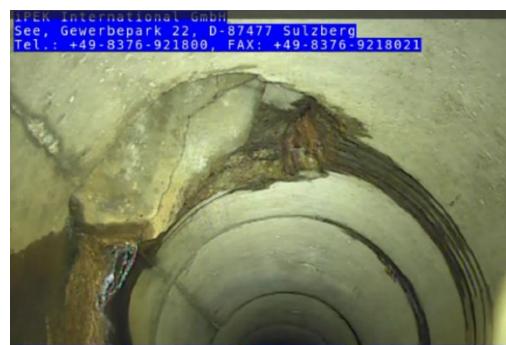
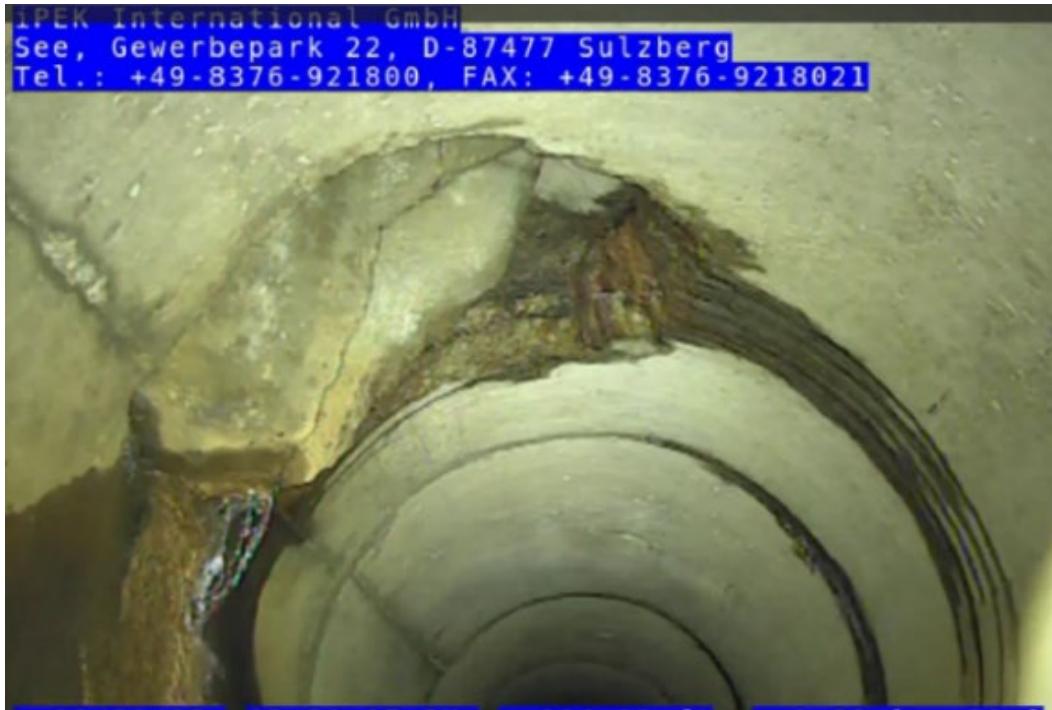
The pipes which were discovered in due course of the CCTV scan revealed a blind pipe connection adjacent to Division G of the cemetery, Figure 23. Further exploration revealed an earthen structure within the cemetery which received French drains from within the cemetery. Visual evidence suggests the system is clogged with mud, (Figure 24), but to state the degree to which this has caused the system to operate at a capacity less than intended would be conjecture. Clear/clean water was observed flowing into the 36" RCP along Elliott Avenue from this French drain system. It can be concluded the system provides some capacity to relieve hydrostatic pressure within the soil from within the cemetery.

Figure 23- CCTV Image within the 36-inch RCP pipe along Elliott Avenue. The blind pipe connection leading to the French drains within the Cemetery can be seen within the center of the frame.

Figure 23 - CCTV Image within the 36-inch RCP pipe along Elliott Avenue. The blind pipe connection leading to the French drains within the Cemetery can be seen within the center of the frame.

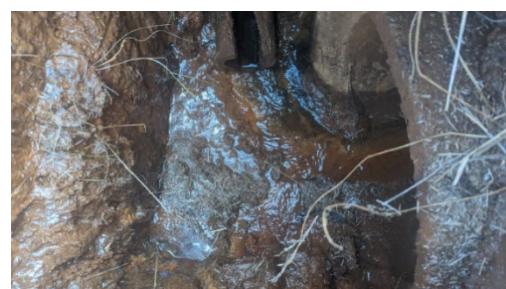
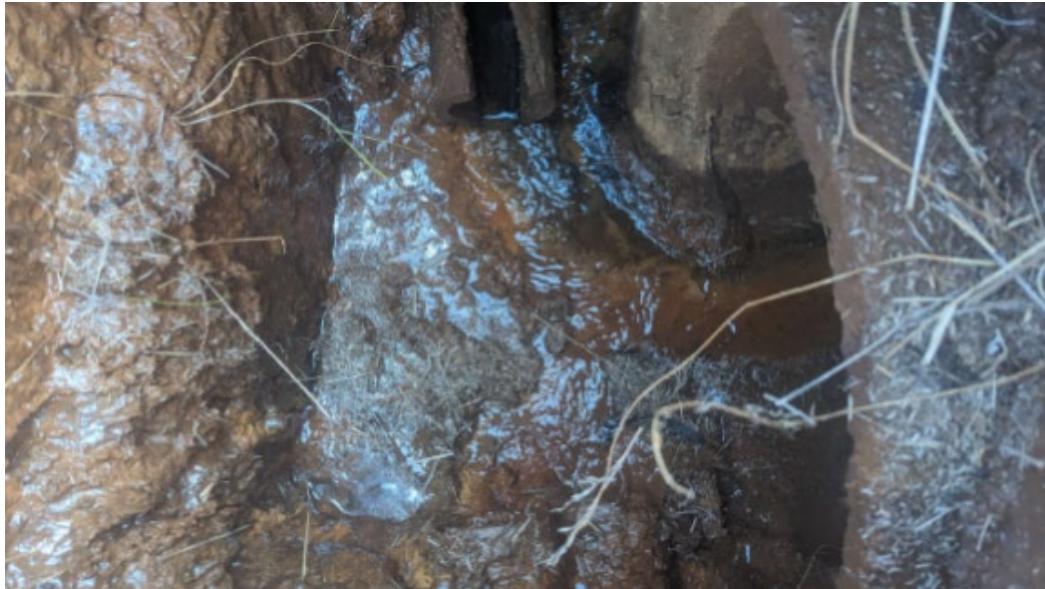
Figure 24 – An earthen manhole type structure connecting the French drains within the cemetery to a pipe which will connect with the 36-inch RCP in Elliott Avenue shown in Figure 21.

Figure 24 - An earthen manhole type structure connecting the French drains within the cemetery to a pipe which will connect with the 36-inch RCP in Elliott Avenue shown in Figure 21.

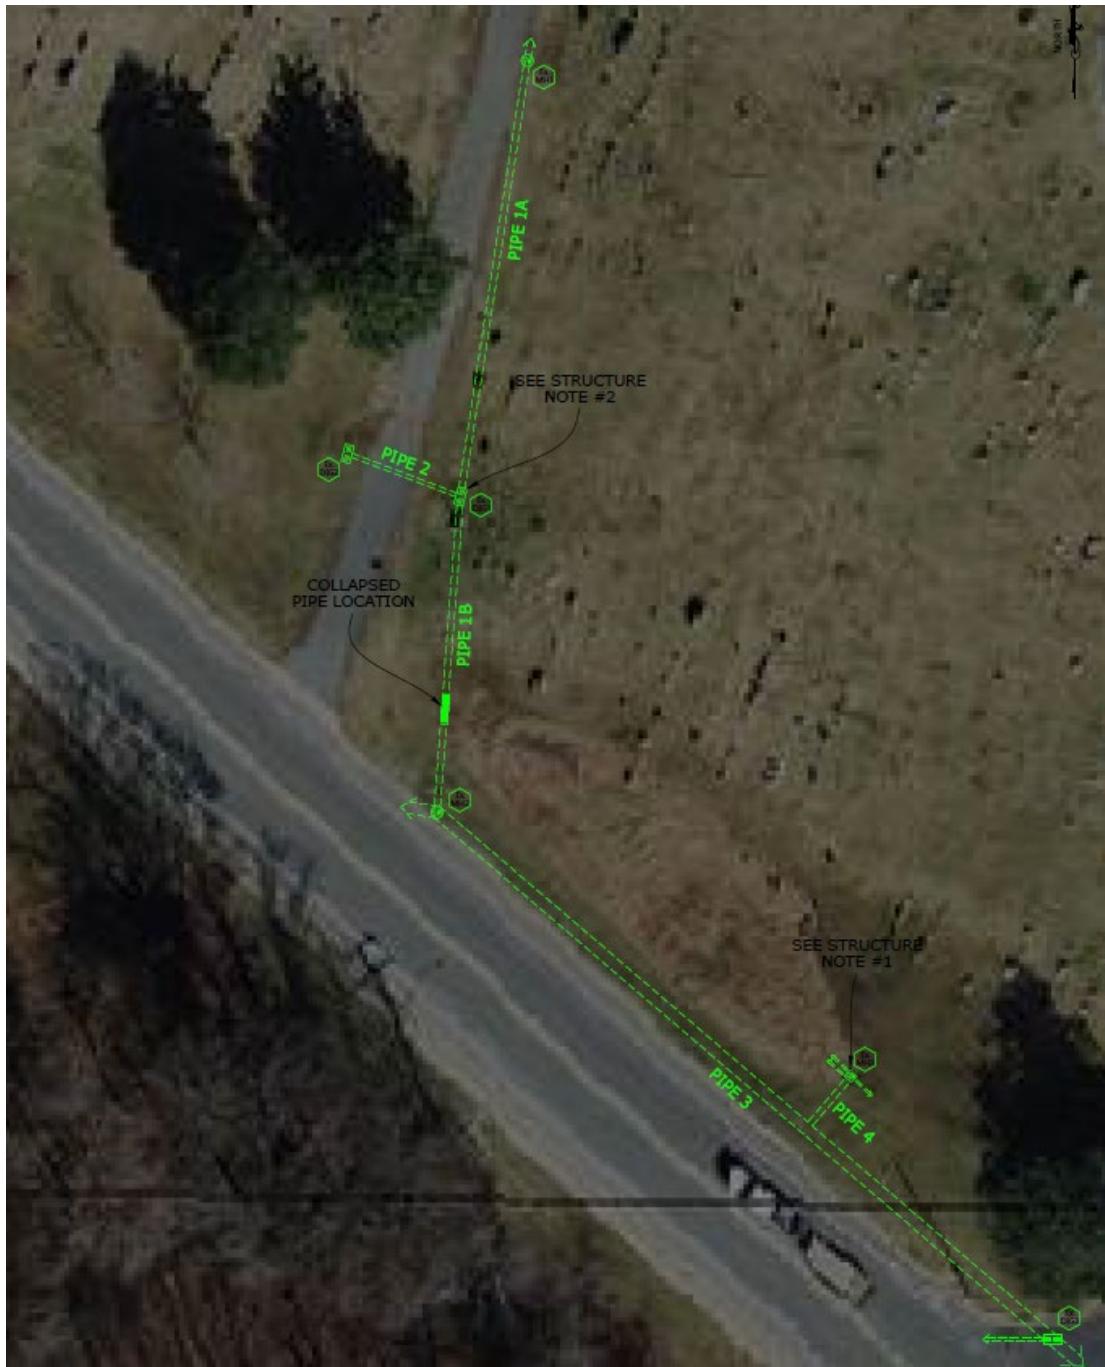
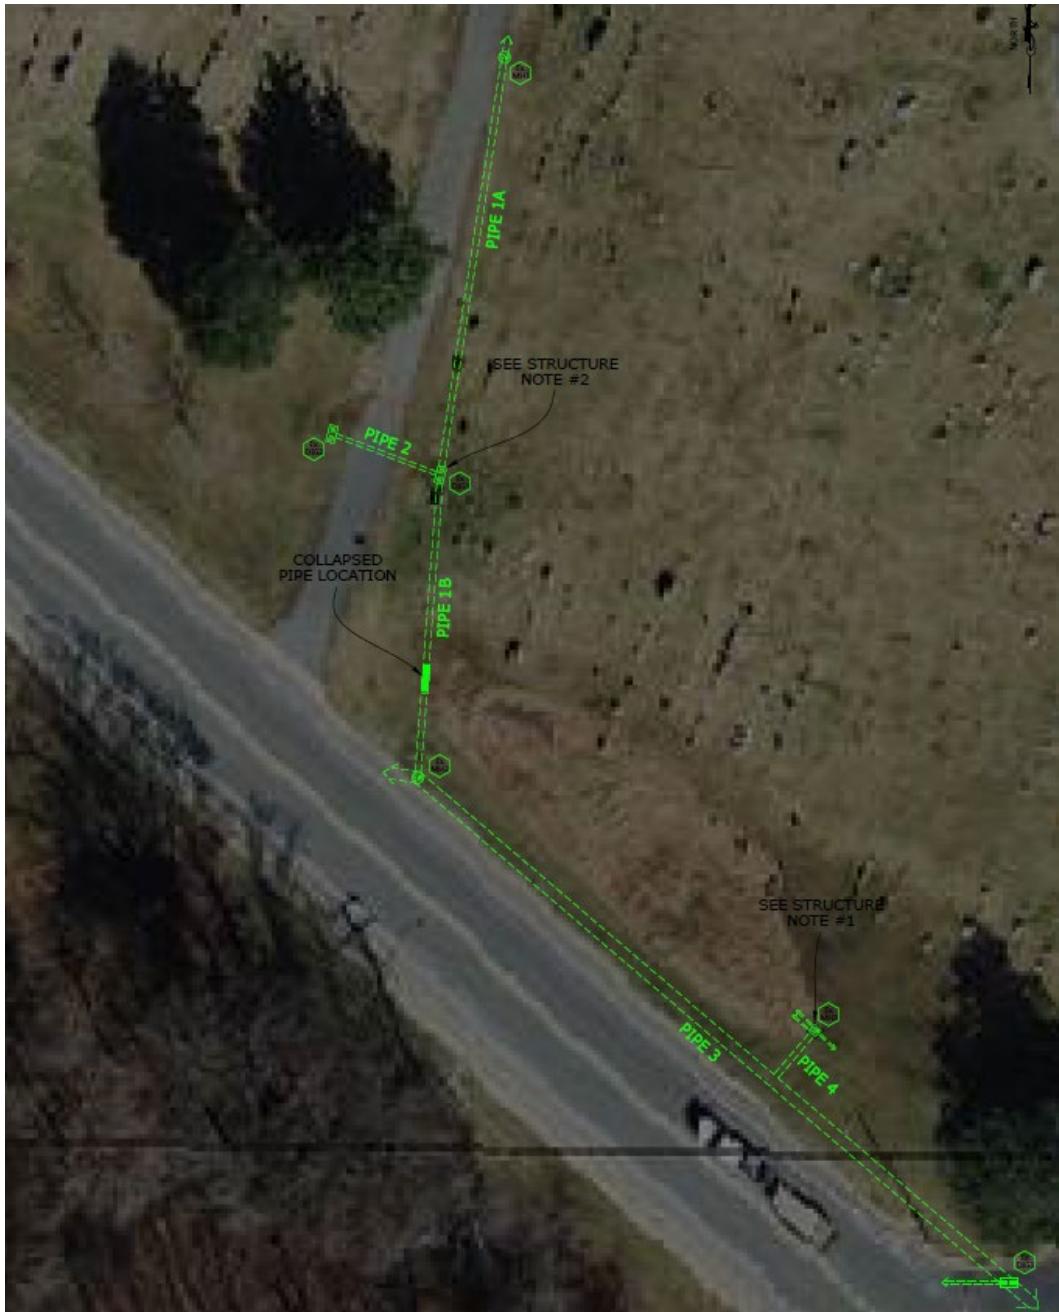
14. Aerial imagery of the subject area, when geolocated in relationship to the broken pipe, suggests a correlation between the broken pipe and the saturated ground in Division G, refer to Figure 25, below.

15. However, it is not likely that the saturated ground is only associated with the broken pipe but rather that the broken pipe, which carries the flow from the original tributary, has likely exacerbated what was likely going to be a condition that was subject to wet soil and soggy conditions based on groundwater flow and the historic evidence that this has always been a low-lying area.

Figure 25 - Note the Location of the broken pipe, and the variation of the ground cover color between the broken pipe and the grounds adjacent to the pipe.

While not explicitly a repair item: the piezometers installed as recommended in 6.2.1 should be maintained and monitored for no less than 12 months after repairs are completed. As previously discussed, the broken pipe is only part of the challenge in this area and with continued monitoring of the piezometers, additional ways to alleviate the saturated ground can be determined and adequately implemented.
