Memorandum

FROM: Daniel C. Hyer
Line and Grade Civil Engineering

DATE: December 5, 2023

RE: Oakwood Cemetery Forensic Investigation

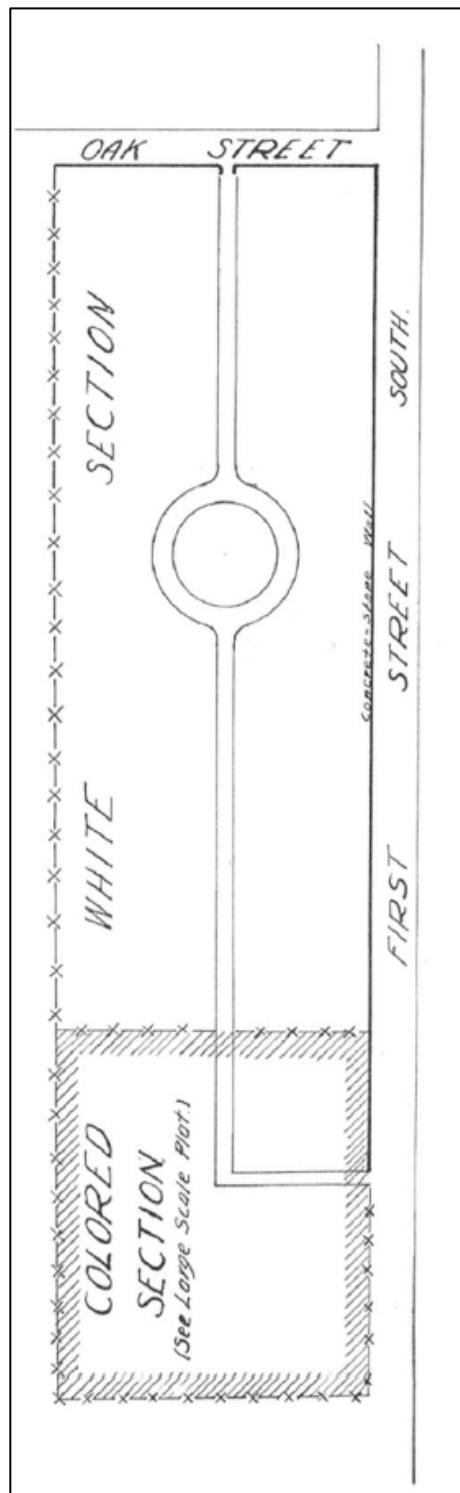
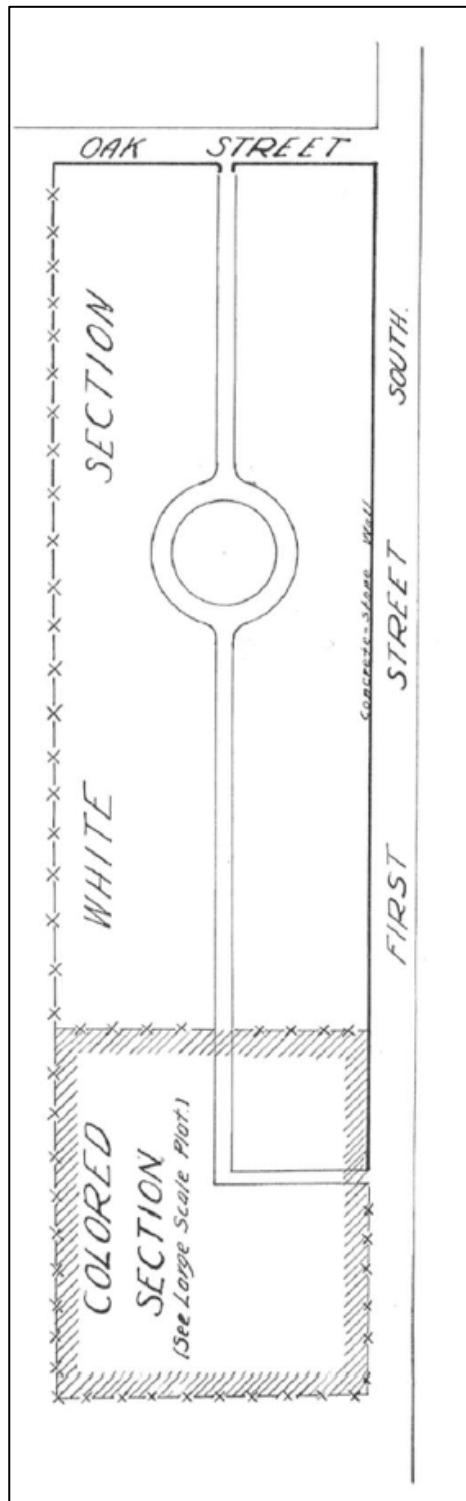
Figure 4 – Plat of Colored Section of Oakwood Cemetery, Charlottesville, Virginia. City of Charlottesville Bureau of Engineering, August 1, 1928.

Note that the future Elliott Avenue would be directly adjacent to the 'colored section' at the bottom of the figure.

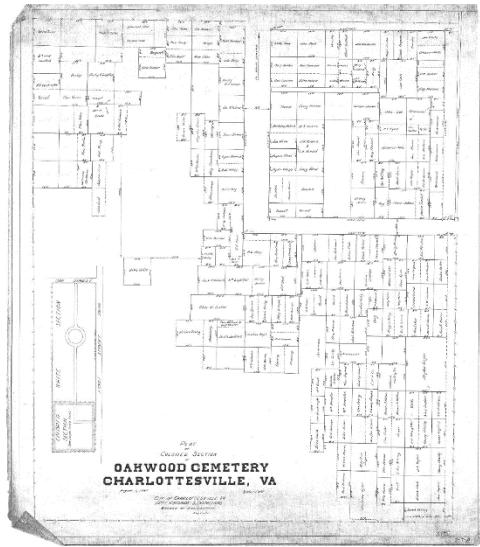
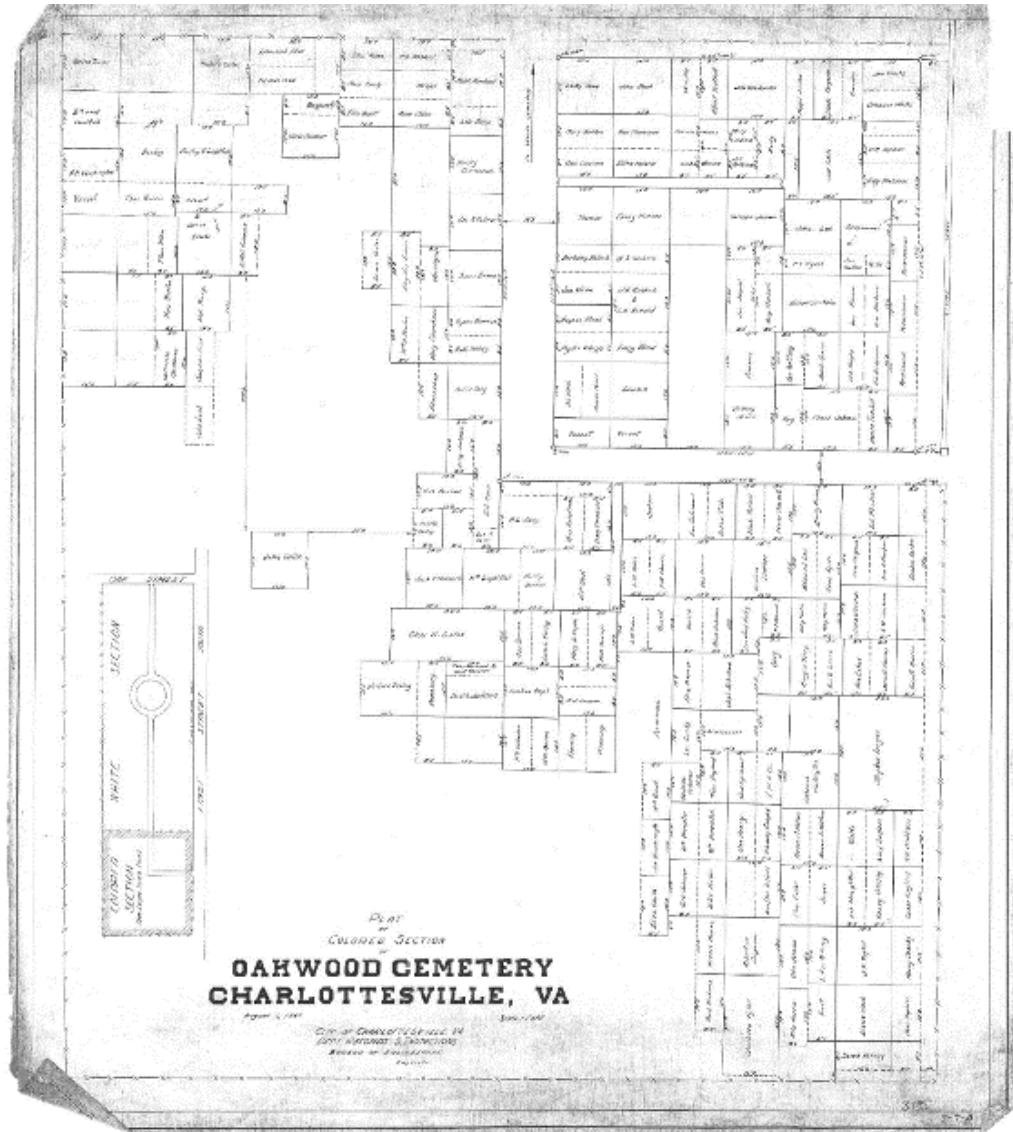
Figure 5 – Plat of Colored Section of Oakwood Cemetery, Charlottesville, Virginia. City of Charlottesville, Bureau of Engineering, August 1, 1928.

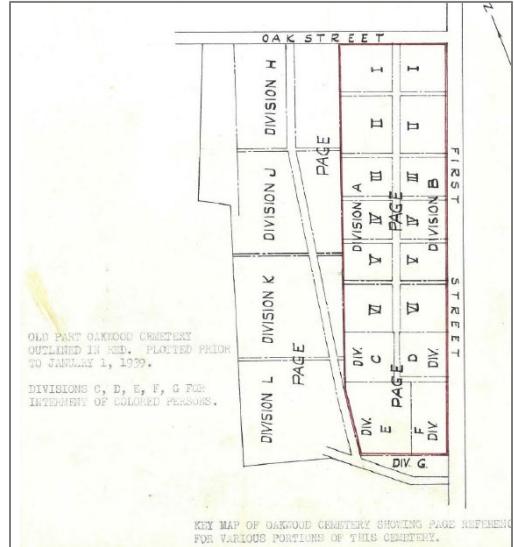
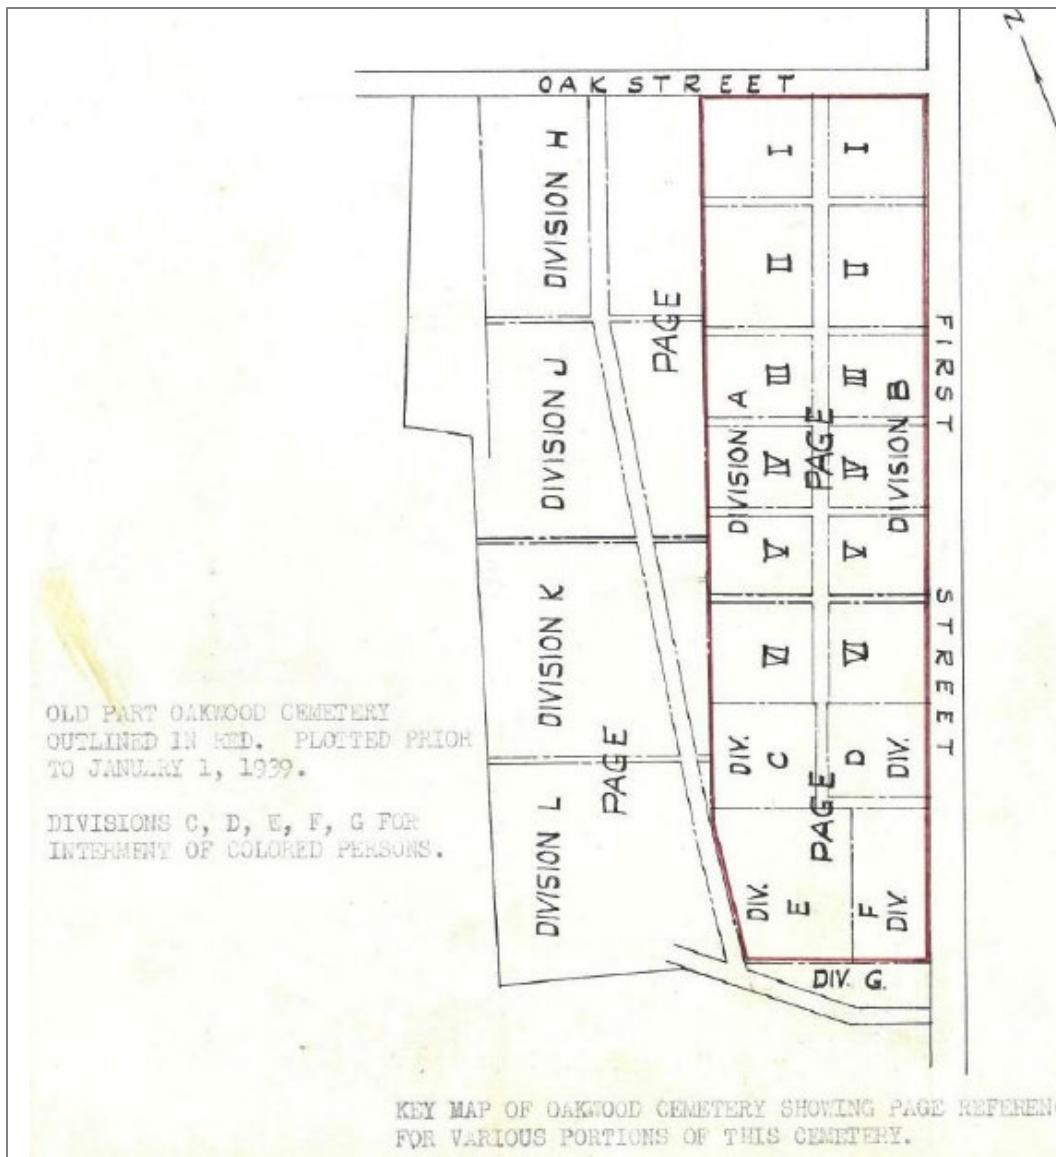
Figure 6 shows the expanded Oakwood Cemetery, to include the additional 7-acre purchase of land to the west and the 0.5-acre parcel to the south. This figure also shows the designations of the cemetery in terms of "Divisions." The African-American sections of Oakwood Cemetery were Divisions C, D, E, F and G.

Figure 6 – Oakwood Cemetery showing the ca. 1863 red-outlined 'old' section at right and the new 1938 western addition at left. Note the small strip of land designated Division G' below and south of the old section of Oakwood Cemetery.

Figure 6 – Oakwood Cemetery showing the ca. 1863 red-outlined 'old' section at right and the new 1938 western addition at left. Note the small strip of land designated 'Division G' below and south of the old section of Oakwood Cemetery.

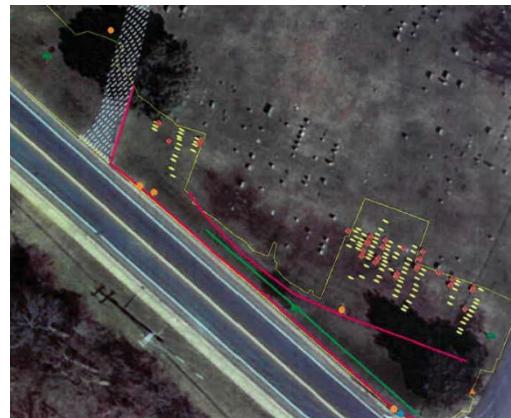
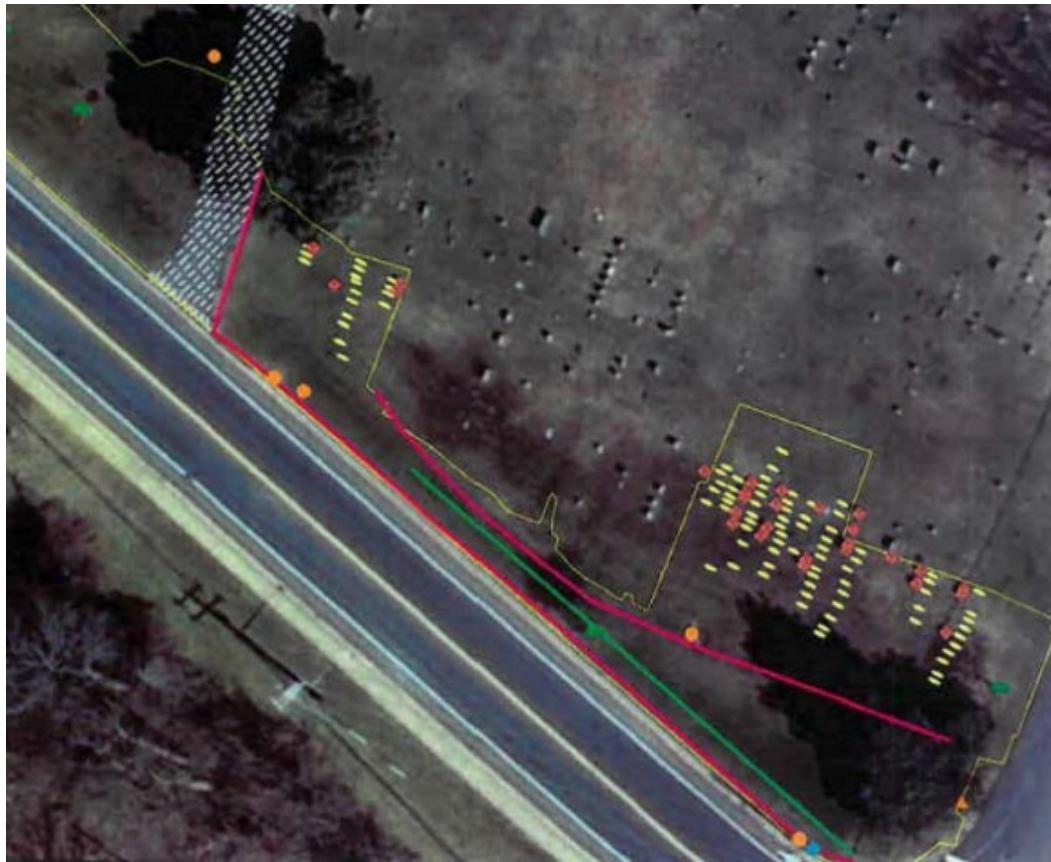
In 2017, The City of Charlottesville hired NAEVA Geophysics, Inc. to conduct a ground penetrating radar (GPR) survey of the area adjacent to and north of Elliott Avenue in advance of proposed plans to construct a sidewalk in this location. Figure 7 shows the findings of this GPR Survey. The findings of the NAEVA GPR scan suggest that there are burial sites within Division G that are unmarked, which is to say, there are individuals who have been buried but there is not a corresponding surface demarcation such as a gravestone. What the study does not say, and what cannot be explicitly stated, is if the unmarked graves correspond with City records, or not. The NAEVA study can be found in Appendix B.

Figure 7 – Plan showing location of buried utilities (red and green lines), and grave like anomalies (yellow) and grave markers (red). The thin yellow outline represents the study area. NAEVA Geophysics, Inc., 2017.

Note the shading of the ground in relation to the study area and the area known to be saturated.

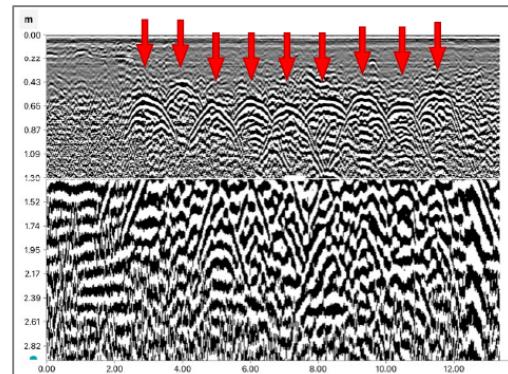
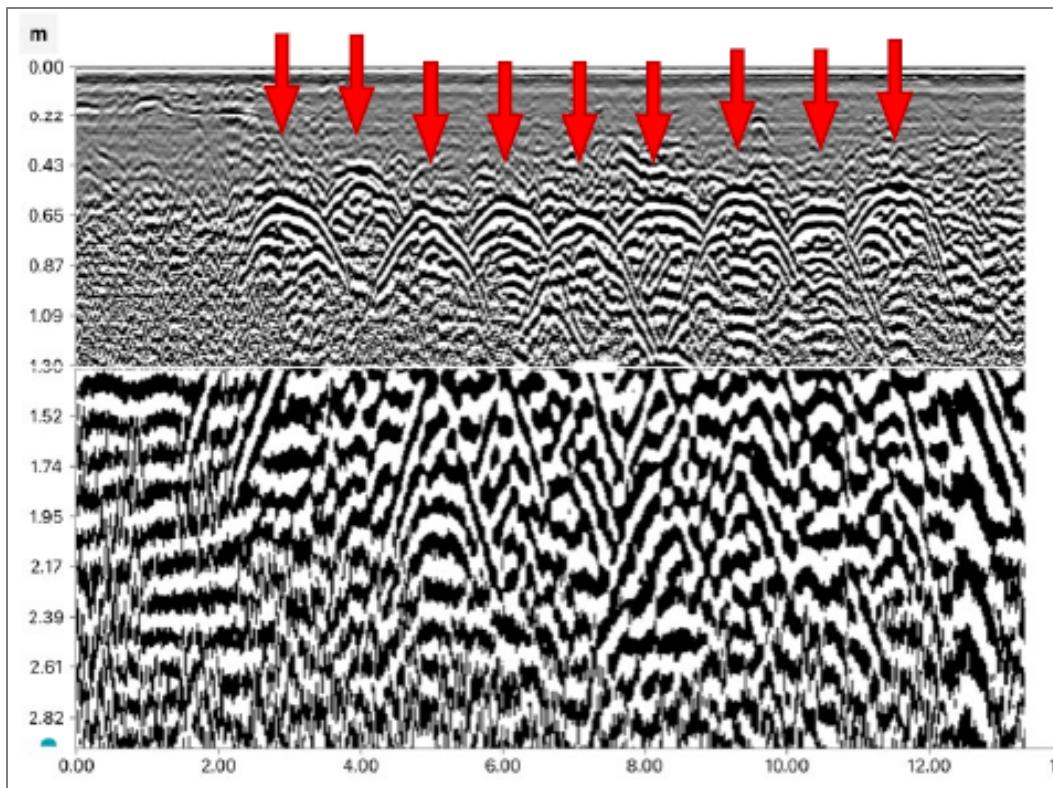
Our team collected GPR data along several burial rows and the graphic imaging positively correlated burial sites with geophysical imagery from the GPR device (Figure 8). Having performed this baseline diagnostic scan, our team attempted to scan for unmarked burials within the study area. In areas where the soils were dry it could be determined that no unmarked grave sites were present. These areas where the soil was dry and scanning could be performed in a satisfactory manner were located on the west side of the north-south cemetery road (Figure 9). On the east side of the north-south road, where the soils were saturated, the GPR scan was ineffective. Wet soils create geophysical anomalies within the scanning imagery, thus the presence of unmarked graves within the study, where the soils were saturated, could not be confirmed.

Figure 8 - Successful GPR Scan. Red arrows identify grave like anomalies corresponding with marked graves. Please note, this image was from

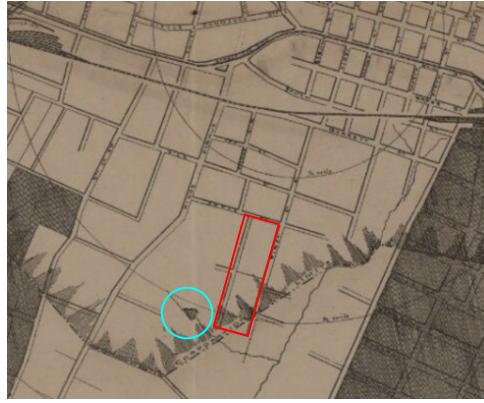
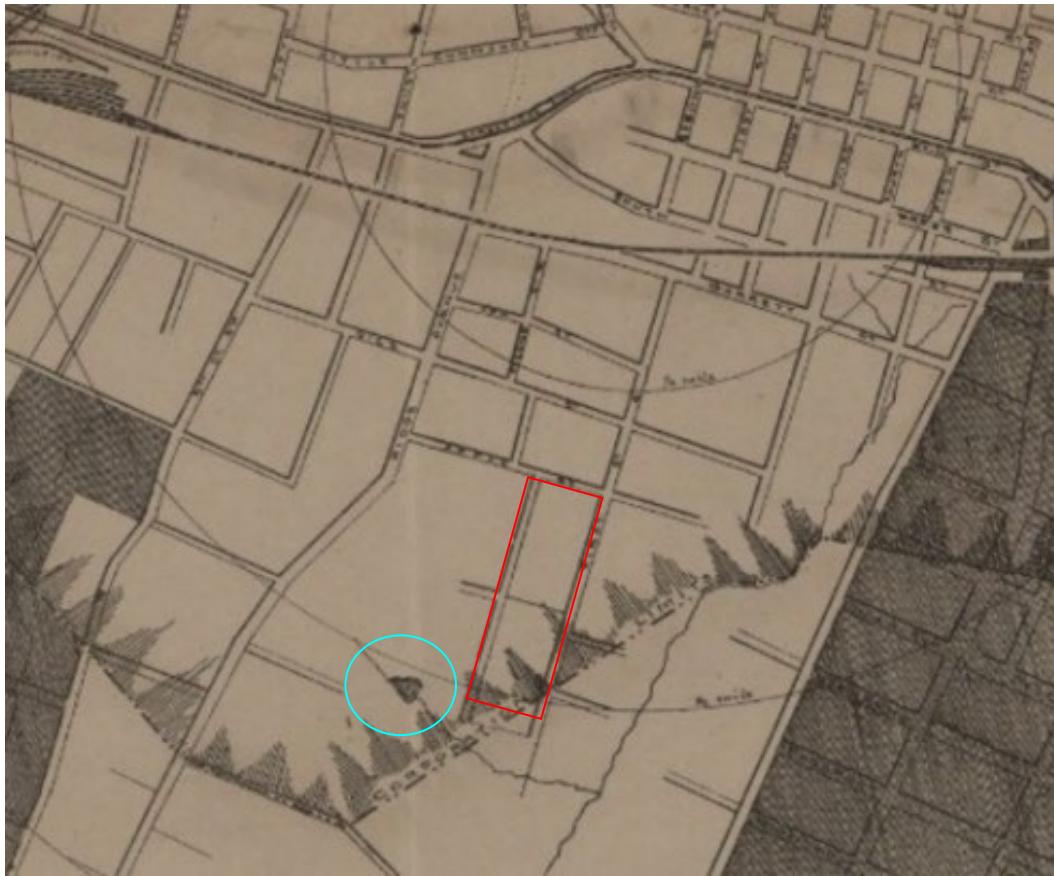
A late nineteenth-century map of the vicinity indicates the landscape contained tributaries and ponds as the watershed flowed toward Pollocks Branch, refer to Figure 10. Locating this map relative to Oakwood Cemetery places this pond very near the location where the saturated ground is currently manifest.

Figure 10 – Map of property owned or controlled by the Charlottesville Land Co., Charlottesville, VA, showing the ca. 1863 red-outlined 'old' section of Oakwood Cemetery, and the blue circle around a pond which flowed toward Pollock's Branch.

Figure 10 – Map of property owned or controlled by the Charlottesville Land Co., Charlottesville, VA, showing the ca. 1863 red-outlined 'old' section of Oakwood Cemetery, and the blue circle around a pond which flowed toward Pollocks Branch.

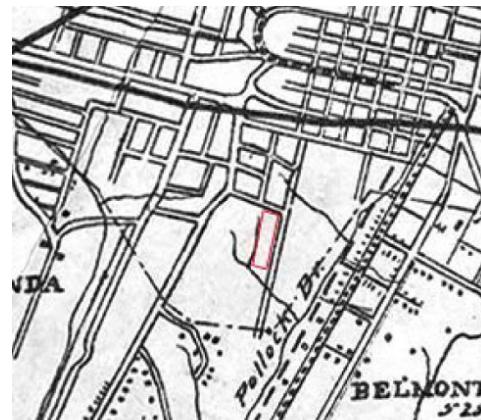
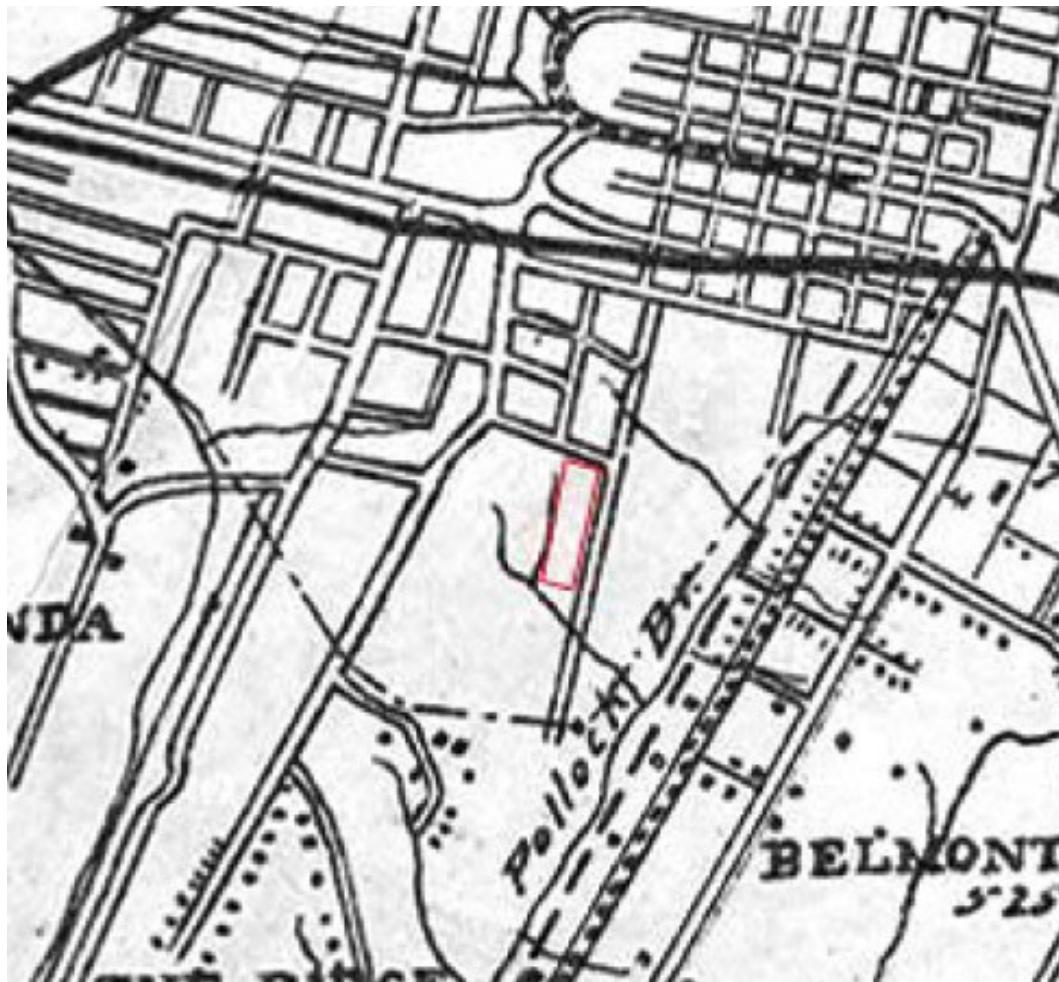
Evidence that the land contained these tributaries is further supported by other archived maps, including an early twentieth-century map which also shows an unnamed tributary west of Pollocks Branch, lying directly west of what would become Oakwood Cemetery, refer to Figure 11.

Figure 11 – Map showing the approximate, red-outlined location of the ca. 1863 'old' section of Oakwood Cemetery and its adjacent southern and western tributary drainage features.

Figure 11 – Map showing the approximate, red-outlined location of the ca. 1863 'old' section of Oakwood Cemetery and its adjacent southern and western drainage features.

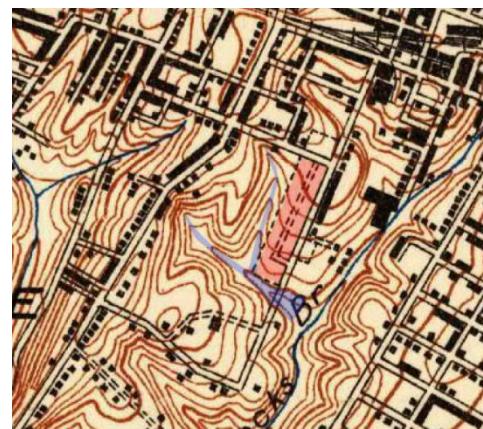
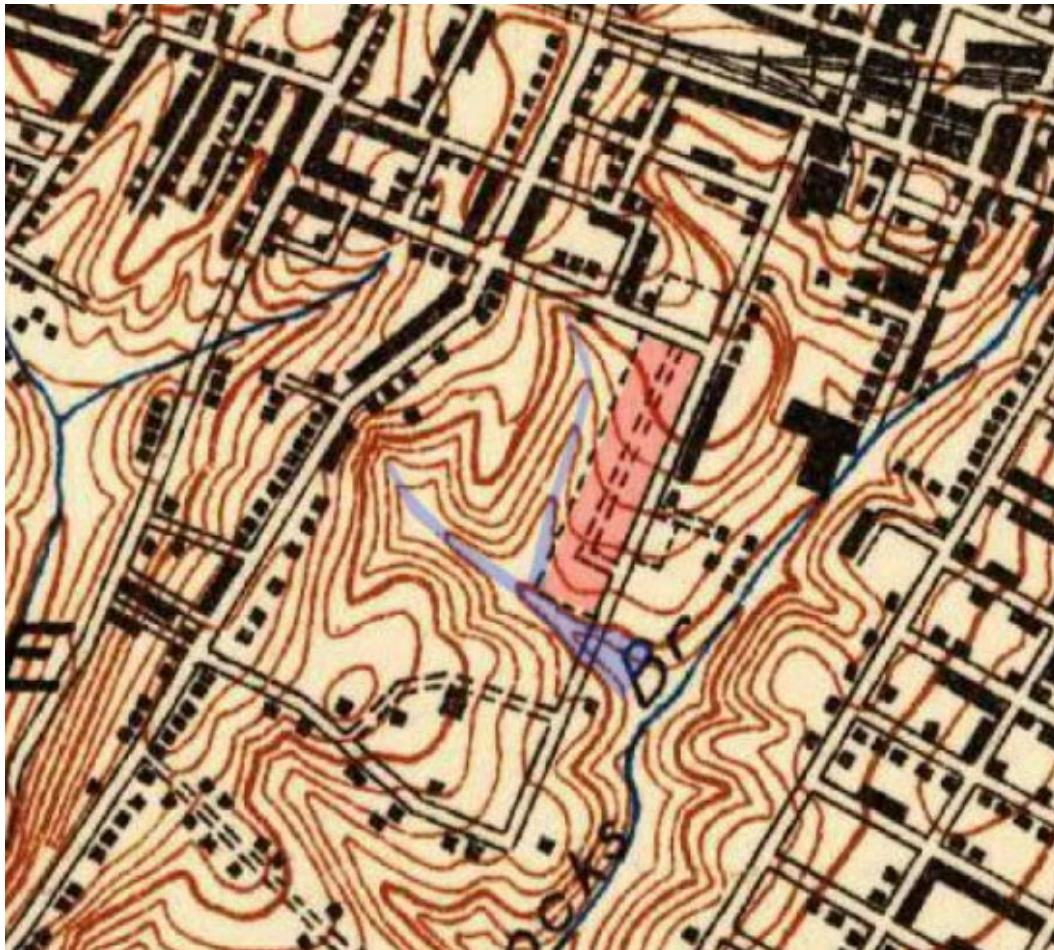
What these two initial maps (Figures 10 and 11) do not portray is the topographic data. It can be assumed that these tributaries were associated with low-lying areas in the landscape. However, in 1935, a USGS topographic map of the Charlottesville vicinity documents the topography of this area, see Figure 12. This map provides the link between the unnamed tributaries adjacent to Oakwood Cemetery and the topography which indicates low-lying stream-bed type features.

Figure 12 - Charlottesville and Vicinity, showing the red-shaded (ca. 1863) 'old' section of Oakwood Cemetery and the blue-shaded drainages west and south of it following the topographic relief. Notice how the southern drainage broadens into a floodplain south of Oakwood Cemetery at its intersection with Pollock's Branch. U.S.G.S., 1935.

Figure 12 - Charlottesville and Vicinity, showing the red-shaded (ca. 1863) 'old' section of Oakwood

Cemetery and the blue-shaded drainages west and south of it following the topographic relief. Notice how the southern drainage broadens into a floodplain south of Oakwood Cemetery at its intersection with Pollock's Branch. U.S.G.S., 1935.

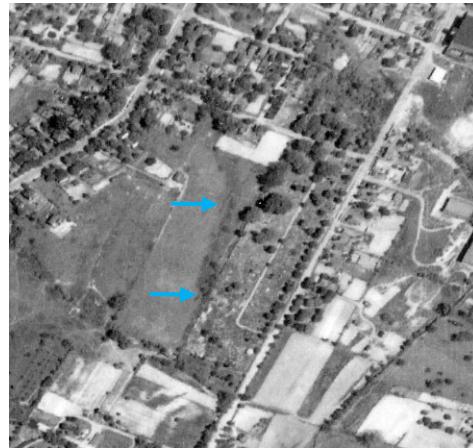
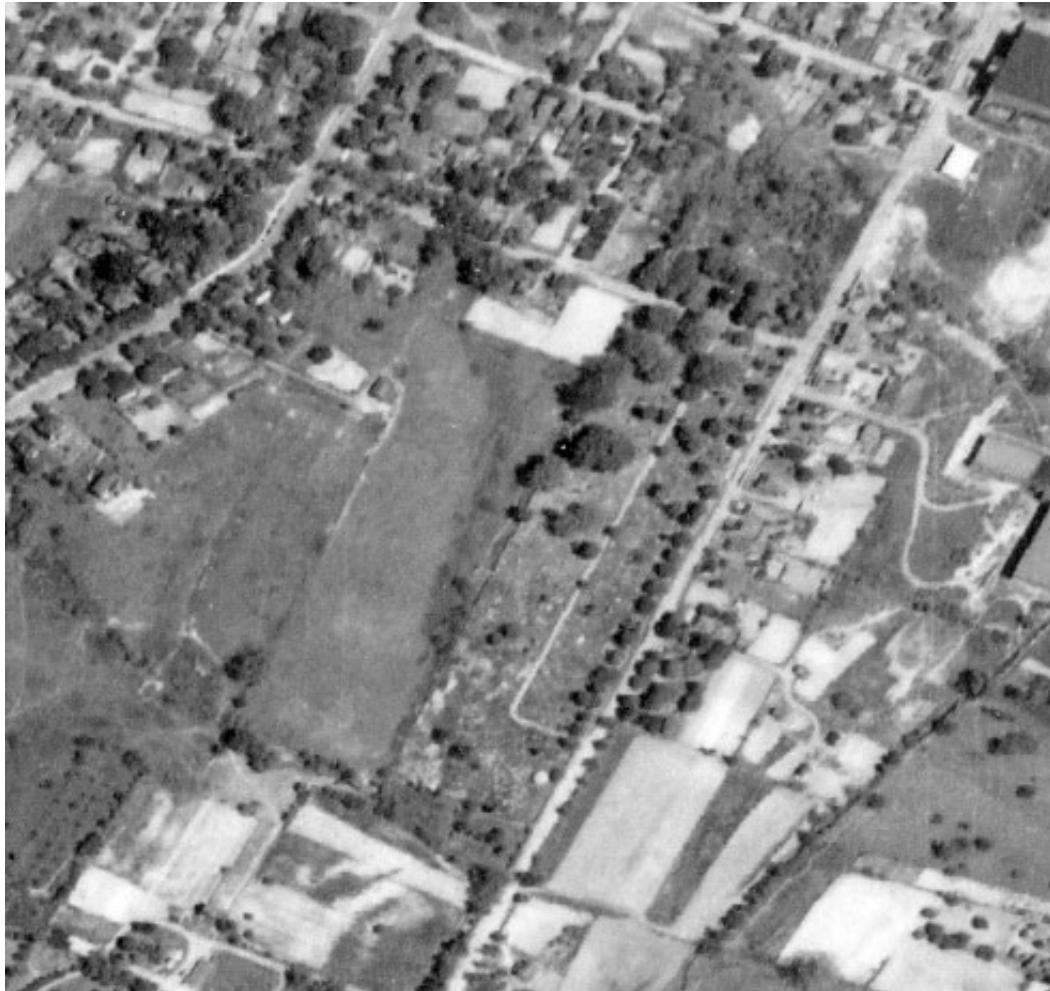
The first aerial photographs of Oakwood Cemetery and its vicinity were taken in 1937. In Figure 13, the extent of the original Oakwood Cemetery can be observed. Additionally, natural drainage tributaries corresponding with the original historic maps and the USGS map can be seen in actual form.

Figure 13 - Aerial photograph from 1937 showing the approximate location of the red-shaded ca. 1863 'old' section of Oakwood Cemetery. Note the presence of the darker colored vegetation, the northern leg of the unnamed drainage of Pollock Branch, to the west of the old section of Oakwood Cemetery.

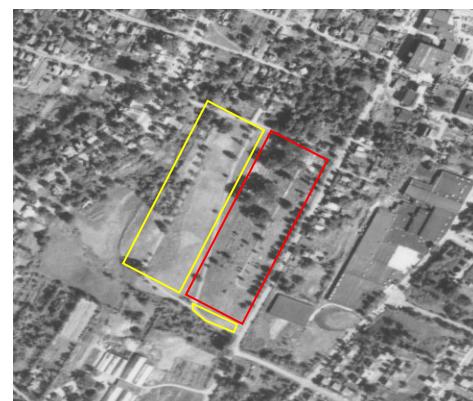
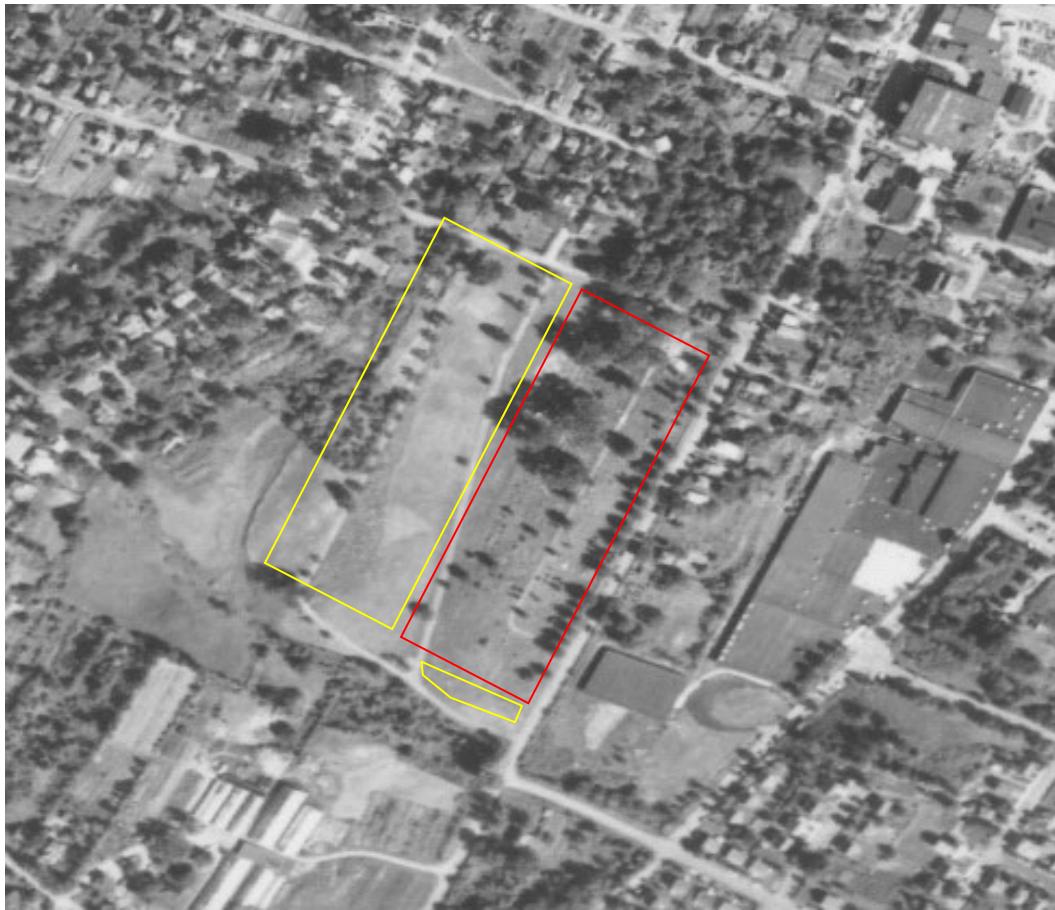
Subsequently, an aerial photo from 1957 (Figure 14) indicates the expanded cemetery and the installation of the north-south cemetery road. This road occupies nearly the same location as the original tributary. Going on, the Oakwood Cemetery plat shows this road and a "15 inch Storm Sewer In Place," refer to Figure 15.

Figure 14 - Aerial photograph from 1957 showing the red-outlined ca. 1863 'old' section of Oakwood Cemetery and the new yellow-outlined western and southern additions. Note the presence of a new southern road, the precursor to Elliott Avenue south of Oakwood, and a spur road connecting Oakmont on the north with 1st Street South on the east.

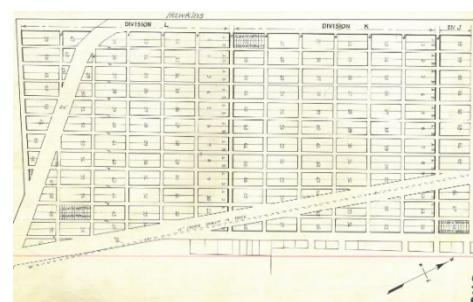
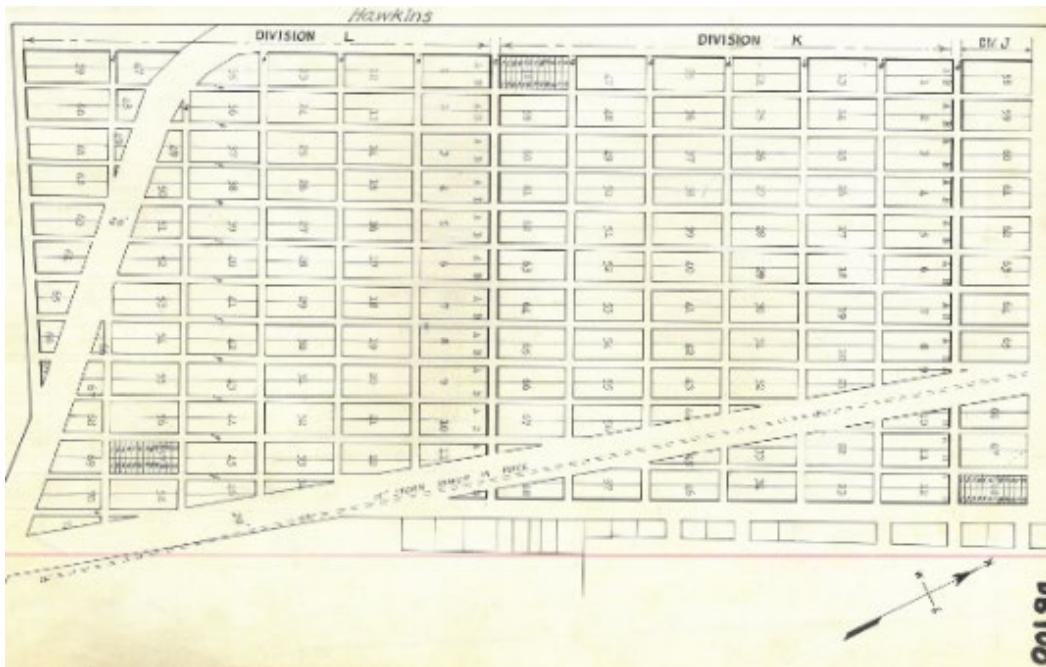
Figure 15 - Plat of the southern end of the western half of Oakwood Cemetery showing the road and a storm drain line paralleling its eastern side. North is to the right. No date [post-1938].

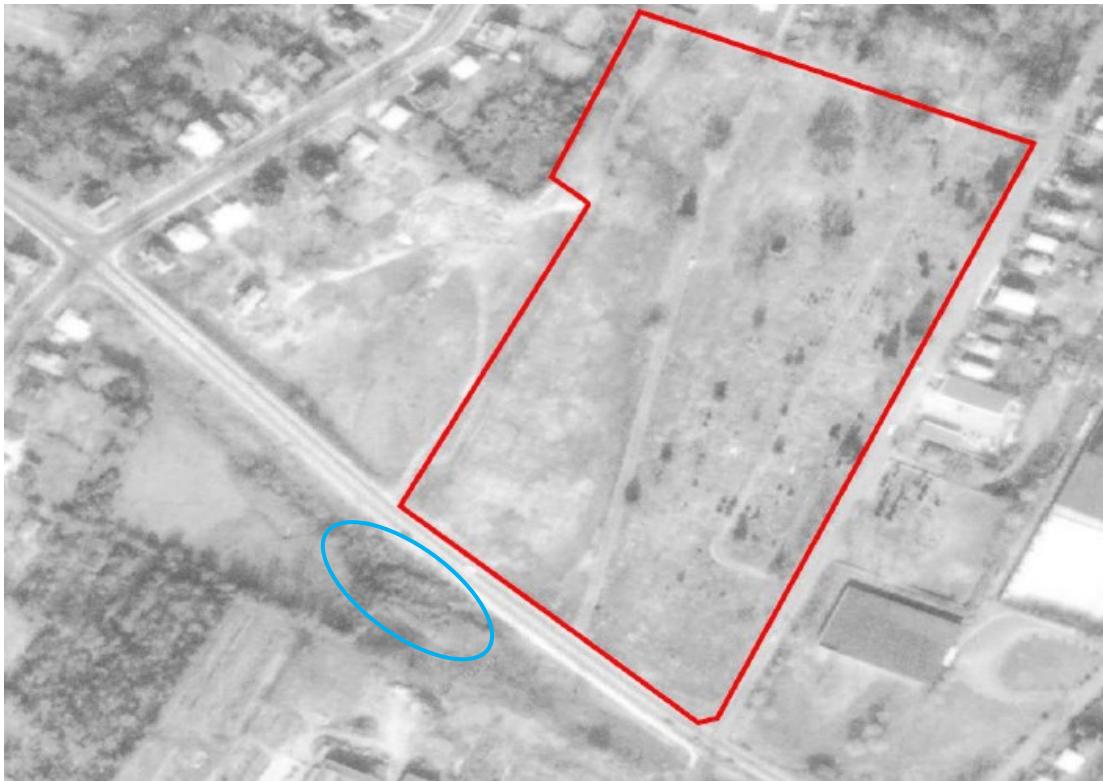
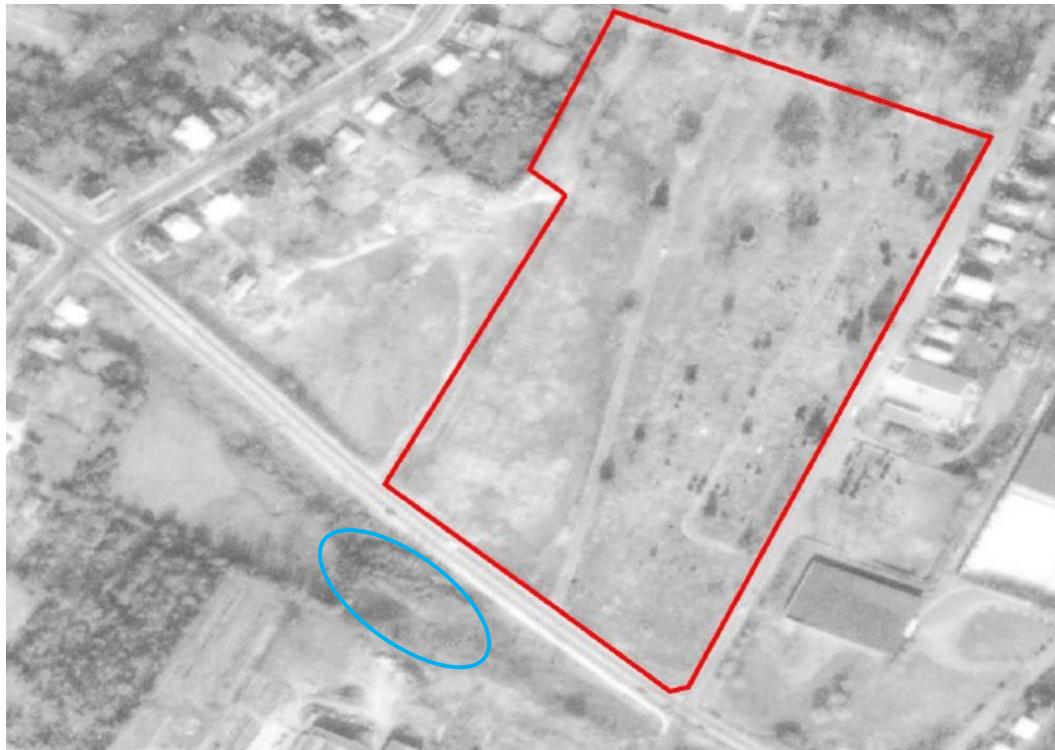
In 1960, the City constructed the Cherry Avenue extension. This roadway reinforced a physical boundary to the cemetery as well as a hydrologic boundary. In Figure 16, (following page) an aerial image from 1966, shows the completed roadway corridor flanking the southern boundary of Oakwood Cemetery.

Figure 16 – An aerial photograph from 1966 showing the boundary of Oakwood Cemetery (in red) and a new western extension of Elliott Avenue extending to the west to meet Ridge Street. Note the small remnant of the original tributary to the south of Elliott Avenue (in blue).

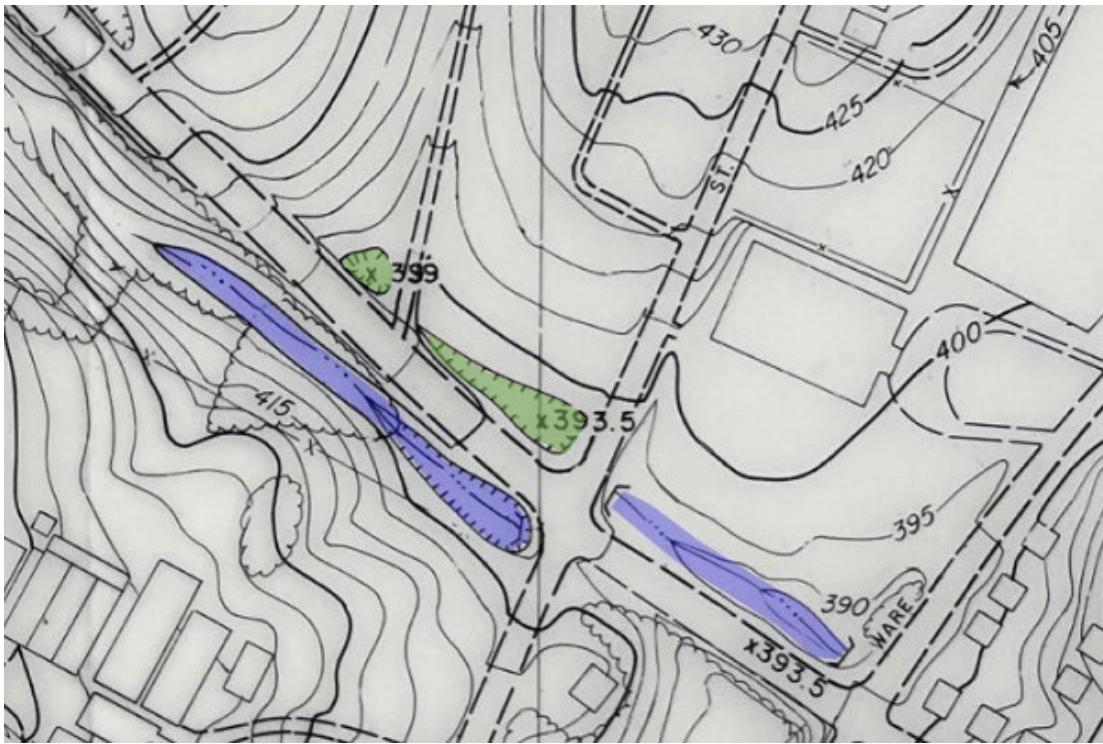
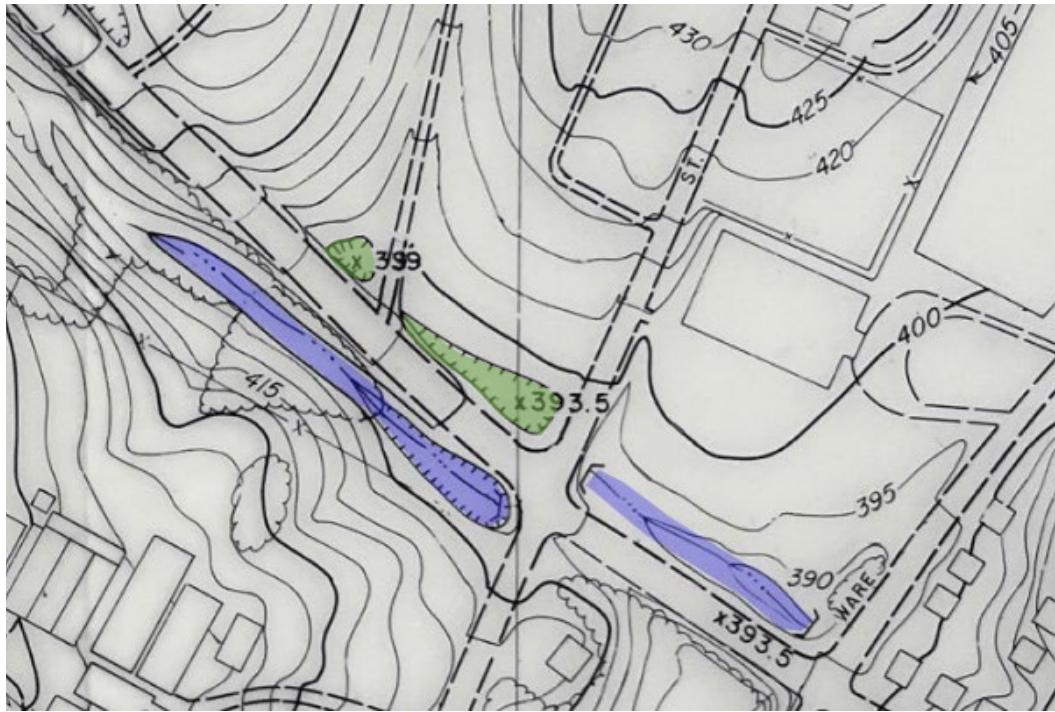
Furthermore, a topographic map from 1970 from the vicinity of Oakwood Cemetery shows the impact of construction of Elliott Avenue on the unnamed drainage tributaries. The topographic map, Figure 17 (following page), suggests that the construction of Cherry Avenue extended disrupted the natural flow of this tributary.

Figure 17 – A topographic map showing the vicinity of Oakwood Cemetery and the location of what remains of the natural tributary low-lying areas (blue shade). Also note the low-lying formed to the north of Elliott Avenue and they are specifically demarcated by a different line-type in the survey (green shade).

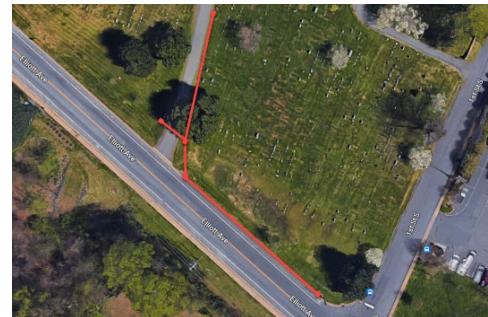
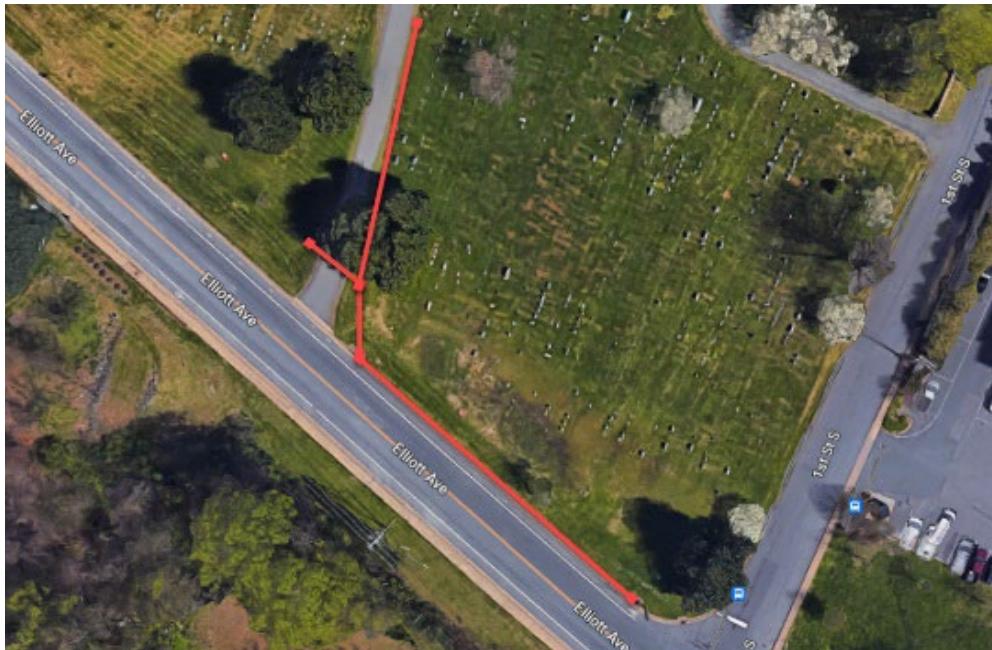
Upon mobilization to the site, it was the intention of the field crew to scan the 4 pipes shown in Figure 18.

Figure 18 – Map showing four known storm sewer pipes (red lines) in within the study area.
